VEHICLE INSPECTION REPORT

HN67WUU

Skoda Superb 2.0 TDI CR SE L Executive 5dr DSG [7 Speed]

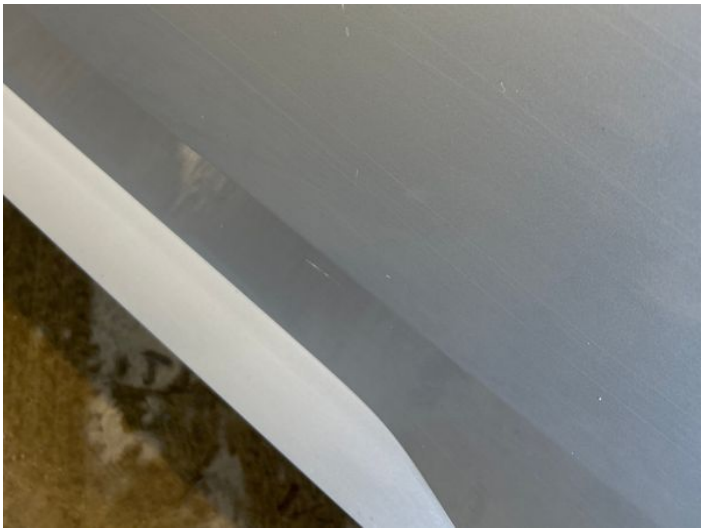
1: Wheel osf
Scratched
Over 50mm

2: Wing osf
Chipped
1 To 5

3: Handle Outer osf
Scratched (Painted)
UpTo 25mm Thru Paint

4: Door osr
Chipped
1 To 5

5: Wheel osr
Scratched
Over 50mm

6: Door osr
Dented
2 Or Less UpTo 10mm
