VEHICLE INSPECTION REPORT

HG12FBN

Honda Jazz 1.4 i-VTEC ES 5dr CVT

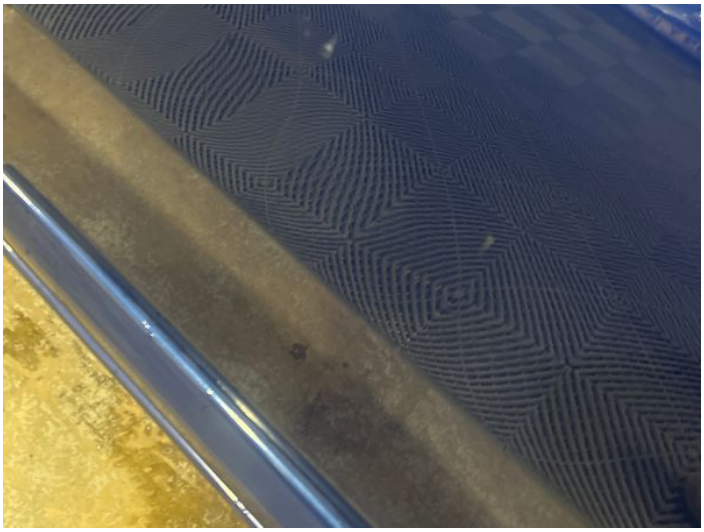
1: Wing osf
Chipped
1 To 5

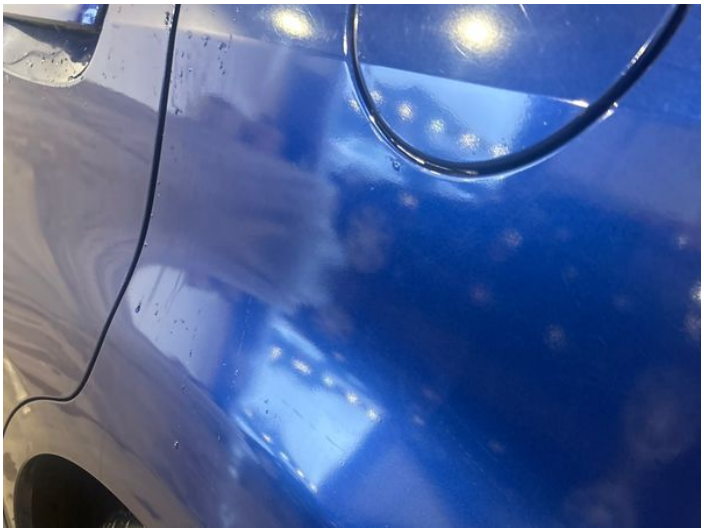
2: Wing osf
Dented
2 Or Less UpTo 10mm
