# VEHICLE INSPECTION REPORT

**GF69AVZ**

## Kia Stonic 1.0T GDi 2 5dr

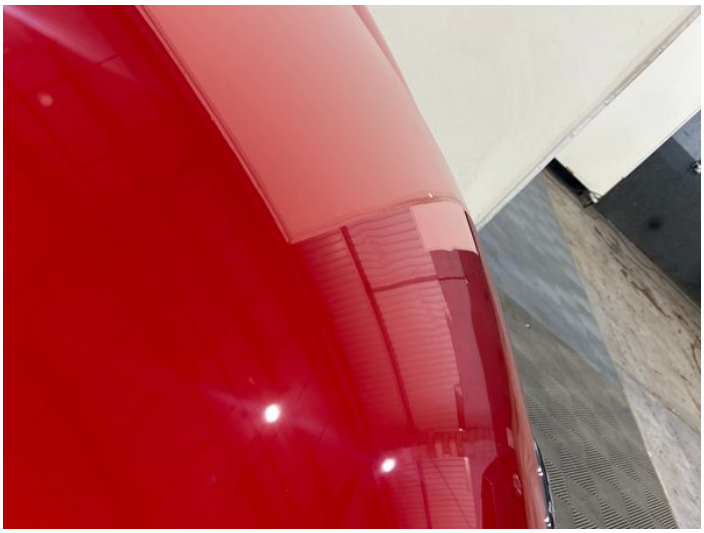
1: Door osr
Chipped
1 To 5

2: Bumper Rear
Poor Previous Repair
Poor Paint

3: Bumper Rear
Chipped
1 To 5

4: Wheel nsr
Corroded
Light

5: Door nsr
Chipped
1 To 5

6: Door nsf
Chipped
1 To 5

7: Wheel nsf
Corroded
Light

8: Bumper Front
Chipped
Multiple Chips

9: Bonnet
Chipped
1 To 5

10: Bumper Rear Moulding
Scuffed (Unpainted)
UpTo 100mm

11: Bonnet
Dented
Between 10mm + 30mm
