VEHICLE INSPECTION REPORT

GX68NFC

BMW 3 Series 320d M Sport 4dr Step Auto

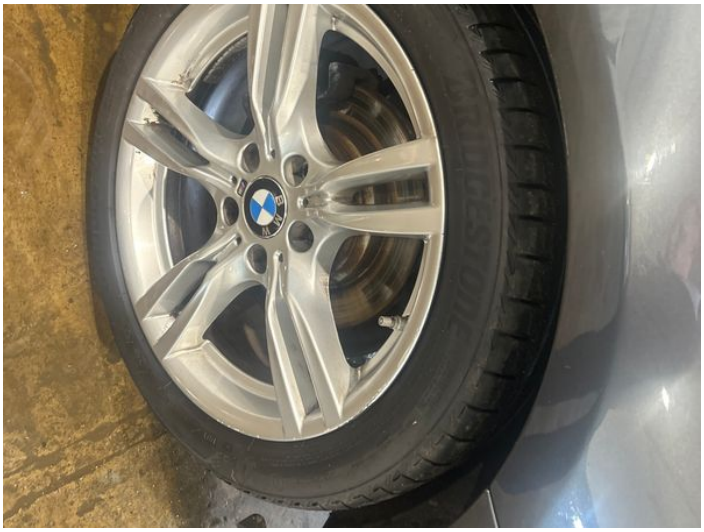
1: Wheel osf
Scratched
Over 50mm

2: Wing osf
Chipped
1 To 5

3: Door osf
Chipped
1 To 5

4: Door osr
Dented
Hail - Moderate

5: Door osf
Chipped
Edge Chip
