VEHICLE INSPECTION REPORT

GY71XRZ

Volkswagen T-Cross 1.0 TSI 110 Active 5dr

nama GRADE 2

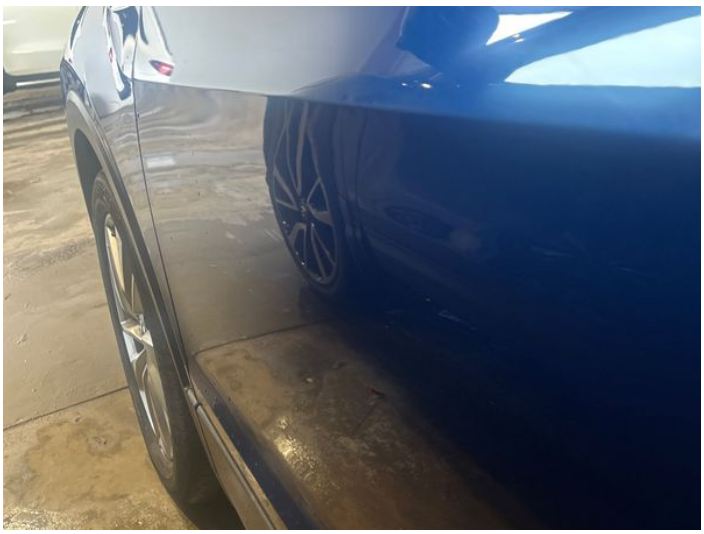
1: Door osf
Chipped
Edge Chip

2: Door osr
Chipped
Edge Chip

3: Wheel nsr
Scratched
Over 50mm

4: Door nsf
Chipped
Edge Chip

5: Wing nsf
Chipped
1 To 5

6: Bonnet
Chipped
1 To 5

7: Door nsr
Dented
Between 10mm + 30mm

8: Door nsf
Dented
2 Or Less UpTo 10mm

9: Wing nsf
Dented
Between 10mm + 30mm

10: Tyre nsf
Damaged
Replace
