VEHICLE INSPECTION REPORT

GL20HUY

Volkswagen Tiguan Allspace 2.0 TDI 4Motion Match 5dr DSG

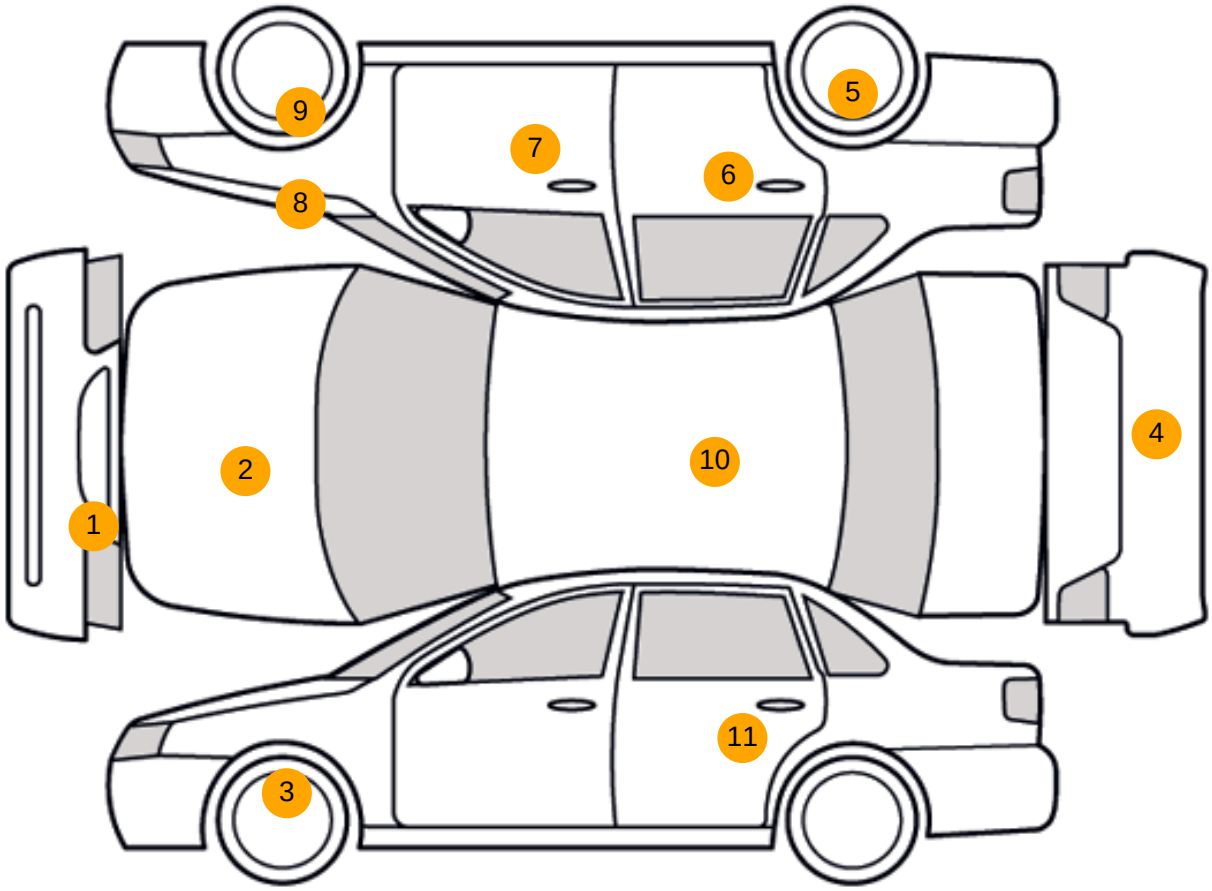
Condition Check

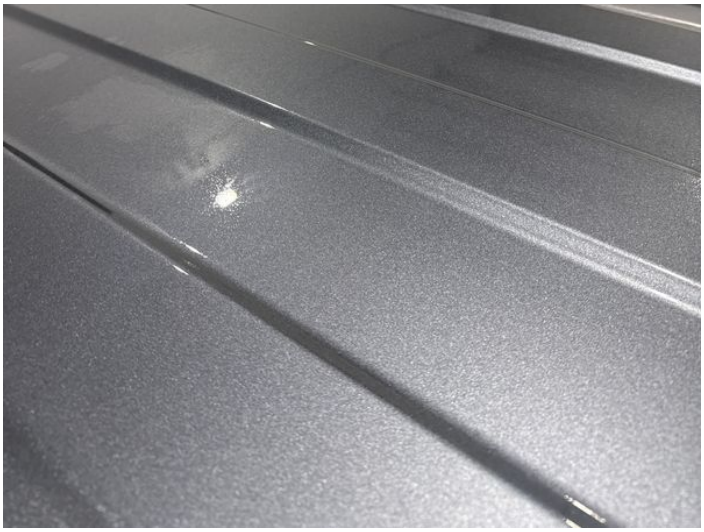
1: Bumper Front
Scratched
25 to 100mm Thru Paint

2: Bonnet
Scratched
UpTo 25mm Thru Paint

3: Wheel nsf
Corroded
Light

4: Bumper Rear
Chipped
1 To 5

5: Wheel osr
Scratched
Over 50mm

6: Door osr
Dented
Between 10mm + 30mm

7: Door osf
Chipped
Edge Chip

8: Wing osf
Chipped
1 To 5

9: Wheel osf
Scratched
Over 50mm

10: Roof
Dented
Over 30mm

11: Door nsr
Poor Previous Repair
Rippled UpTo 30%
