VEHICLE INSPECTION REPORT

GU17GVN

Audi A3 1.4 TFSI S Line 4dr S Tronic

nama GRADE 2

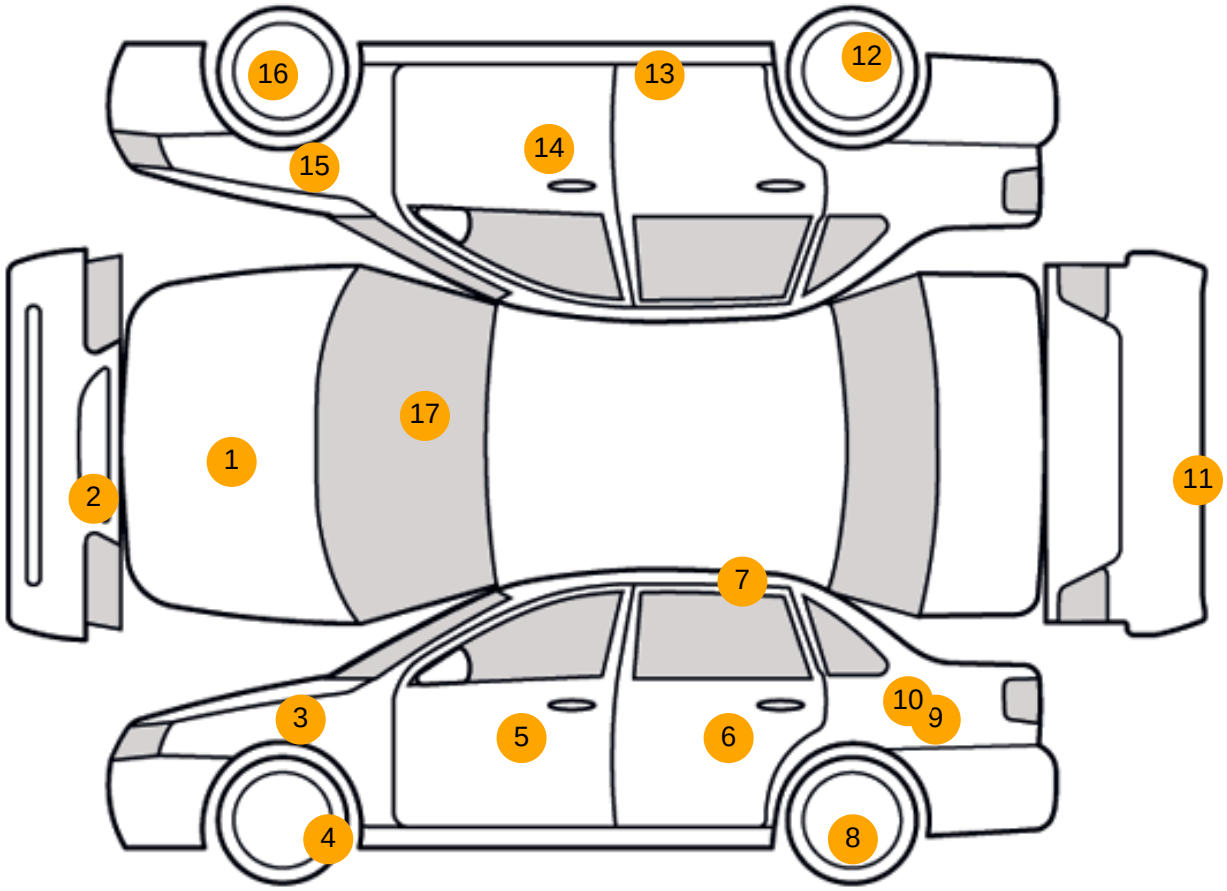
1: Tyre osf
Damaged
Replace

2: Tyre nsf
Damaged
Replace

3: Tyre nsr
Damaged
Replace

4: Bonnet
Chipped
1 To 5

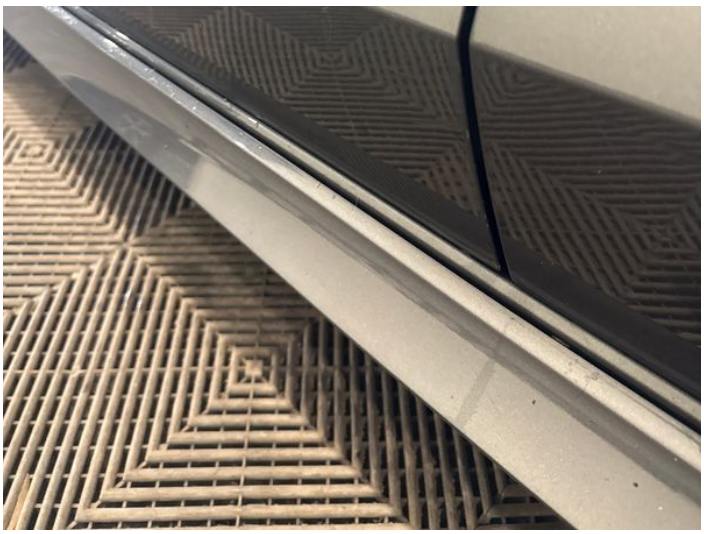
Damage Photos

5: Bumper Front
Chipped
1 To 5

6: Wing nsf
Dented
Between 10mm + 30mm

7: Wheel nsf
Scratched
Over 50mm

8: Door nsf
Chipped
Edge Chip

9: Door nsr
Chipped
1 To 5

10: B Post ns
Scratched
UpTo 25mm Thru Paint

11: Wheel nsr
Scratched
Over 50mm

12: Qtr Panel nsr
Dented
Between 10mm + 30mm

13: Qtr Panel nsr
Scratched
UpTo 25mm Thru Paint

14: Bumper Rear
Scratched
25 to 100mm Thru Paint

15: Wheel osr
Scratched
Over 50mm

16: Sill Panel Trim os
Scratched (Painted)
Over 25mm Thru Paint

17: Door osf
Chipped
Edge Chip

18: Wing osf
Scratched
UpTo 25mm Thru Paint

19: Wheel osf
Scratched
Over 50mm

20: Screen Front
Chipped
UpTo 10mm
