VEHICLE INSPECTION REPORT

GD68UZX

Nissan Qashqai 1.3 DiG-T Tekna 5dr

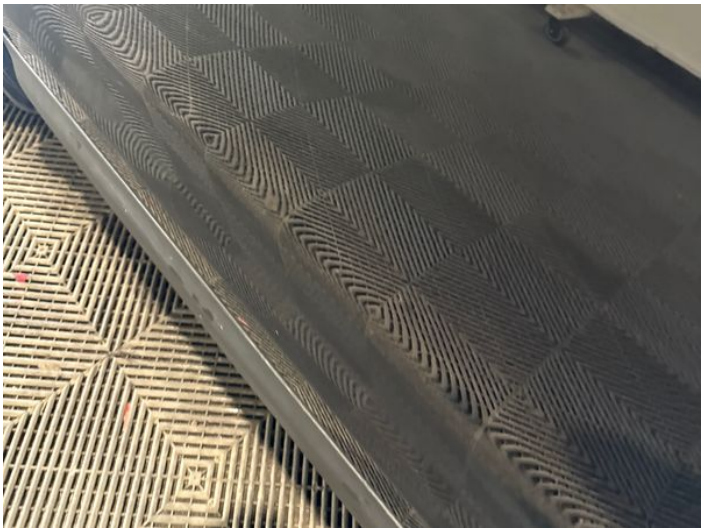
Damage Photos

1: Bonnet
Scratched
Over 25mm Thru Paint

2: Bumper Front
Scratched
25 to 100mm Thru Paint

3: Bumper Front Moulding
Scratched (Painted)
UpTo 25mm Thru Paint

4: Fogdriving Lamp osf
Broken
Replace

5: Wing nsf
Dented
2 Or Less UpTo 10mm

6: Wing nsf
Chipped
1 To 5
