VEHICLE INSPECTION REPORT

GV18GHB

Mini Hatchback 1.5 Cooper II 5dr

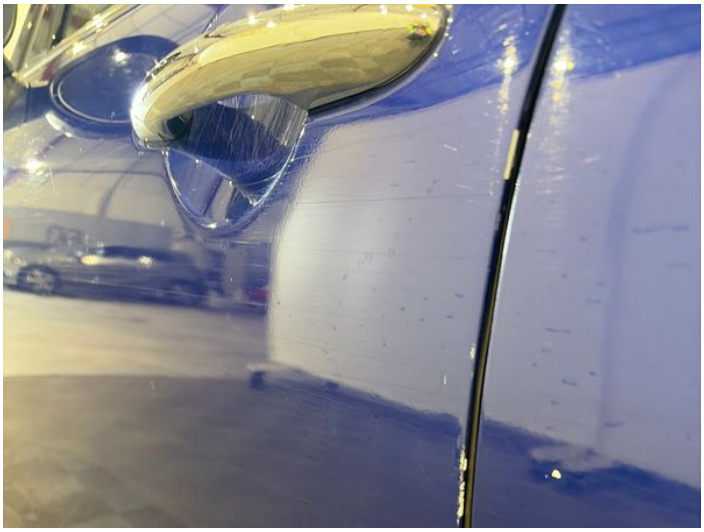
1: Bonnet
Scratched
Over 25mm Thru Paint

2: Bumper Front
Chipped
1 To 5

3: Bumper Front Grill
Broken
Replace

4: Bumper Front
Scratched
25 to 100mm Thru Paint

5: Wheel nsf
Scratched
Over 50mm

6: Wing Front Arch Extension ns
Scuffed (Unpainted)
Over 100mm

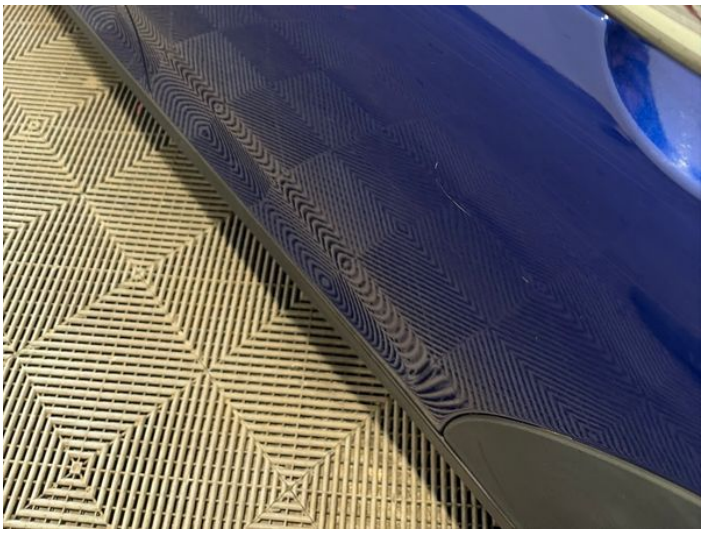
7: Wing nsf
Scratched
Over 25mm Thru Paint

8: Door Mirror Assy nsf
Scratched (Painted)
Over 25mm Thru Paint

9: Door nsf
Dented
Between 10mm + 30mm

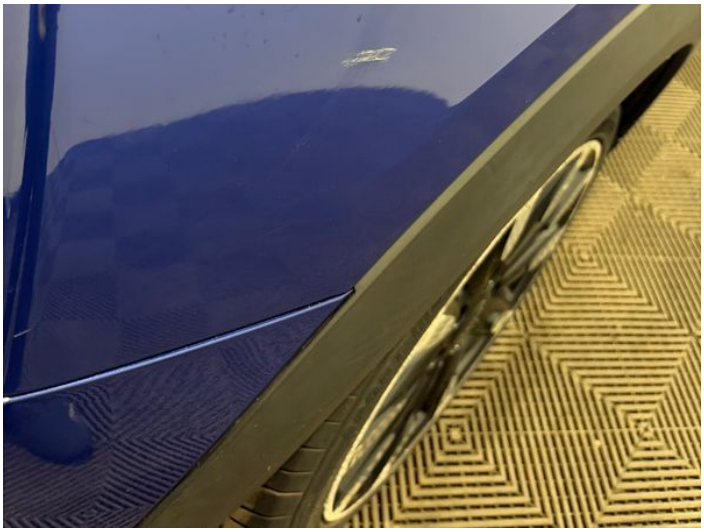
10: Door nsf
Scratched
Over 25mm Thru Paint

11: Door nsr
Poor Previous Repair
Rippled UpTo 30%

12: Wheel nsr
Scratched
Over 50mm

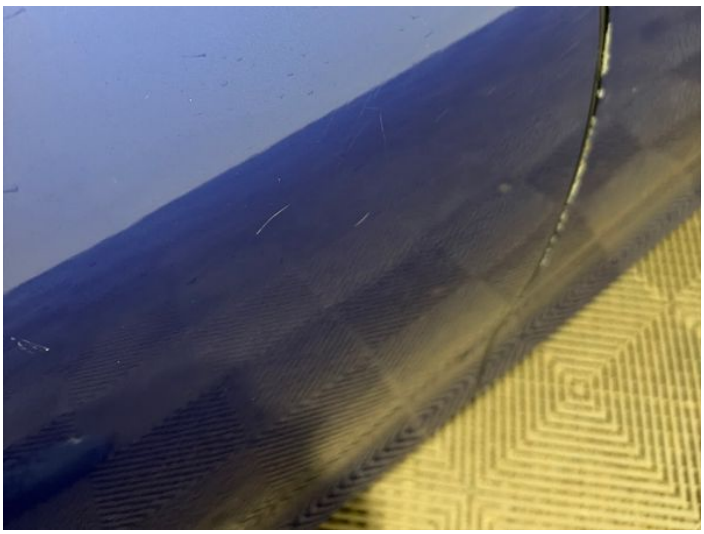
13: Qtr Panel nsr
Dented
With Paint Damage

14: Qtr Panel Moulding ns
Scuffed (Unpainted)
Over 100mm

15: Bumper Rear
Scratched
Over 100mm Thru Paint

16: Qtr Panel osr
Scratched
Over 25mm Thru Paint

17: Wheel osr
Scratched
Over 50mm
