VEHICLE INSPECTION REPORT

WK14XJL

Honda Civic 1.4 i-VTEC S 5dr

nama GRADE 5

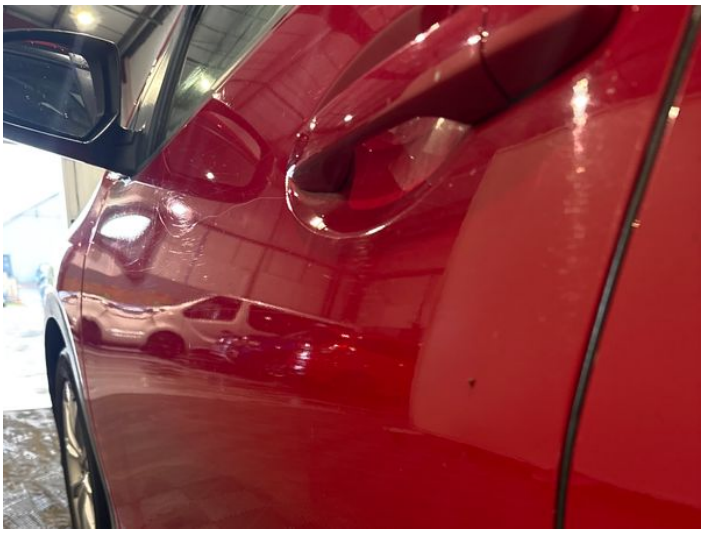
1: Seat Back Cover osf
Scuffed
Over 25mm

2: Door Pad osr
Soiled
Heavy

3: Bonnet
Chipped
Multiple Chips

4: Bumper Front
Poor Previous Repair
Paint Flake

5: Door Mirror Assy nsf
Scratched (Painted)
Over 25mm Thru Paint

6: Wheel nsf
Scratched
Over 50mm

7: Wing nsf
Scratched
Over 25mm Thru Paint

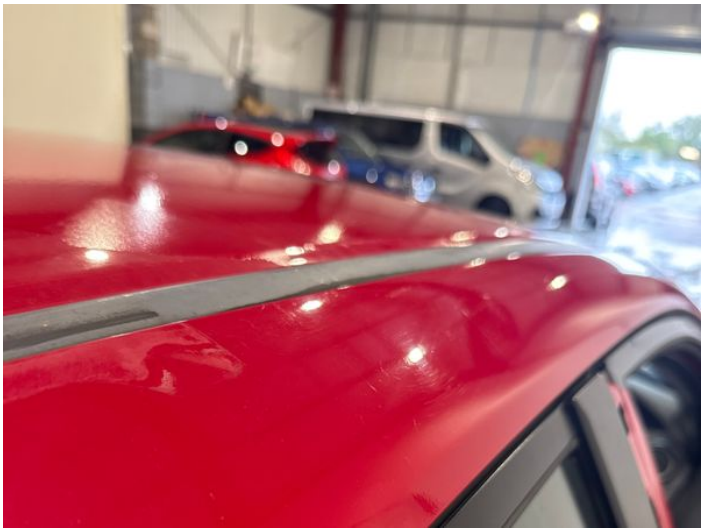
8: A Post os
Dented
Between 10mm + 30mm

9: Roof
Dented
Over 30mm

10: B Post ns
Scratched
Over 25mm Thru Paint

11: Door nsf
Poor Previous Repair
Rippled UpTo 30%

12: Door nsr
Dented
With Paint Damage

13: Wheel nsr
Scratched
Over 50mm

14: Aperture Seal nsr
Broken
Replace

15: Qtr Panel nsr
Scratched
Over 25mm Thru Paint

16: Bumper Rear
Scratched
Over 100mm Thru Paint

17: Boot Lid
Poor Previous Repair
Poor Paint

18: Qtr Panel osr
Scratched
UpTo 25mm Thru Paint
