VEHICLE INSPECTION REPORT

LS60VTW

Mercedes-Benz C Class C220 CDI BlueEFFICIENCY Sport 5dr Auto

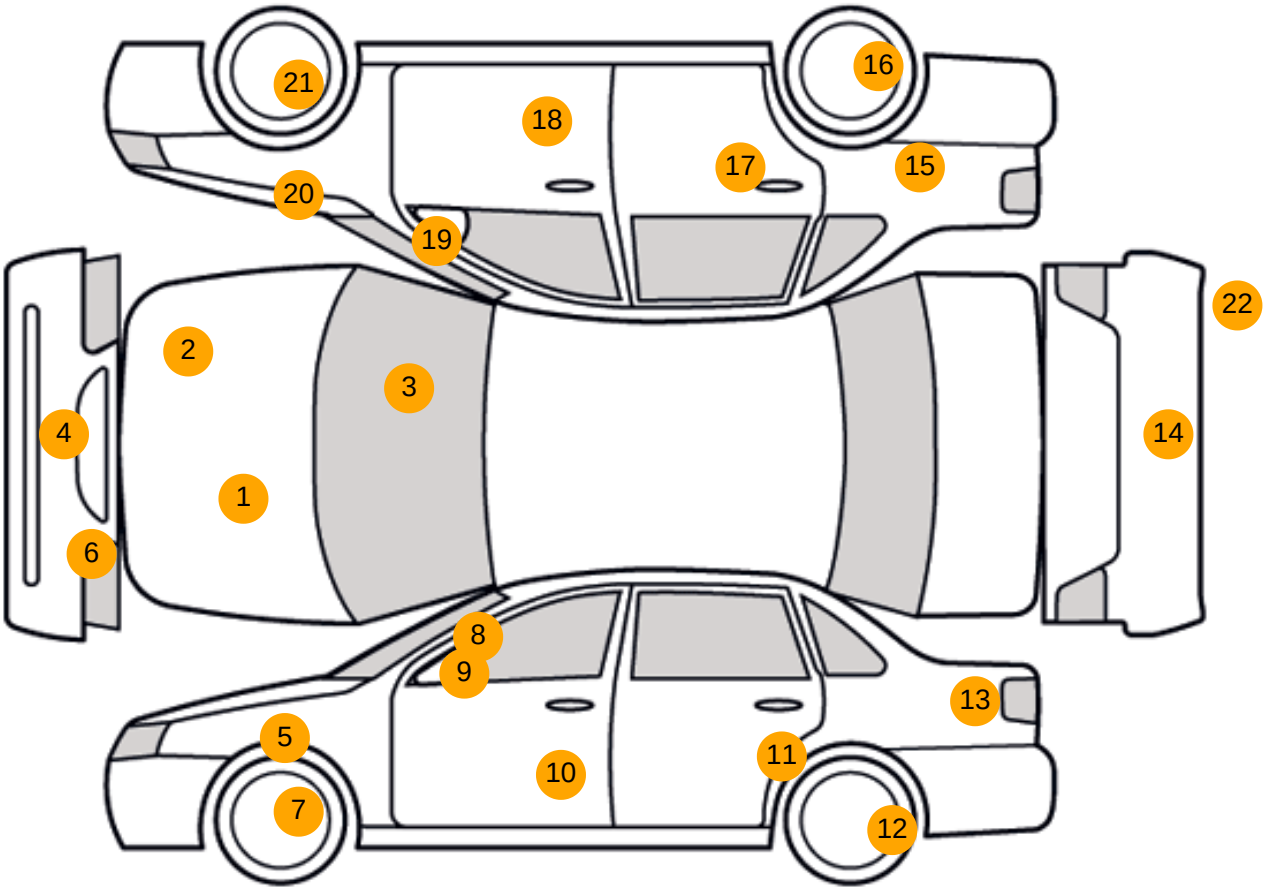
1: Bonnet
Dented
Over 30mm

2: Bonnet
Chipped
1 To 5

3: Screen Front
Cracked
Replace

4: Bumper Front
Dented
With Paint Damage

5: Wing nsf
Poor Previous Repair
Poor Paint

6: Bumper Front
Insecure
Action Required

7: Wheel nsf
Scratched
Over 50mm

8: A Post ns
Scratched
UpTo 25mm Thru Paint

9: Door Mirror Assy nsf
Scratched (Painted)
UpTo 25mm Thru Paint

10: Door nsf
Poor Previous Repair
Poor Paint

11: Door nsr
Poor Previous Repair
Poor Paint

12: Wheel nsr
Scratched
Over 50mm

13: Qtr Panel nsr
Dented
With Paint Damage

14: Bumper Rear
Cracked
Over 25mm

15: Qtr Panel osr
Dented
With Paint Damage

16: Wheel osr
Scratched
Over 50mm

17: Door osr
Dented
With Paint Damage

18: Door osf
Dented
With Paint Damage

19: Door Mirror Assy osf
Scratched (Painted)
Over 25mm Thru Paint

20: Wing osf
Scratched
UpTo 25mm Thru Paint

21: Wheel osf
Scratched
Over 50mm

22: Door Pad osf
Scuffed
Over 25mm

23: Tyre osf
Damaged
Replace

24: Tyre nsf
Damaged
Replace

25: Rear TowEye Cvr
Missing
Replace
