VEHICLE INSPECTION REPORT

HJ55NVA

Honda CR-V 2.0 i-VTEC Executive 5dr Auto

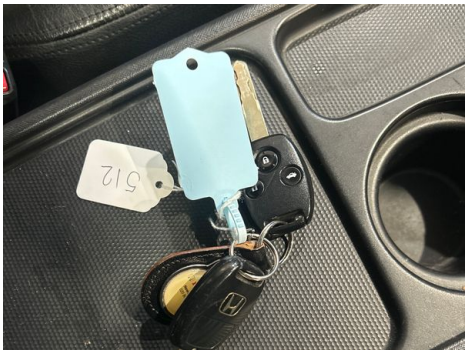
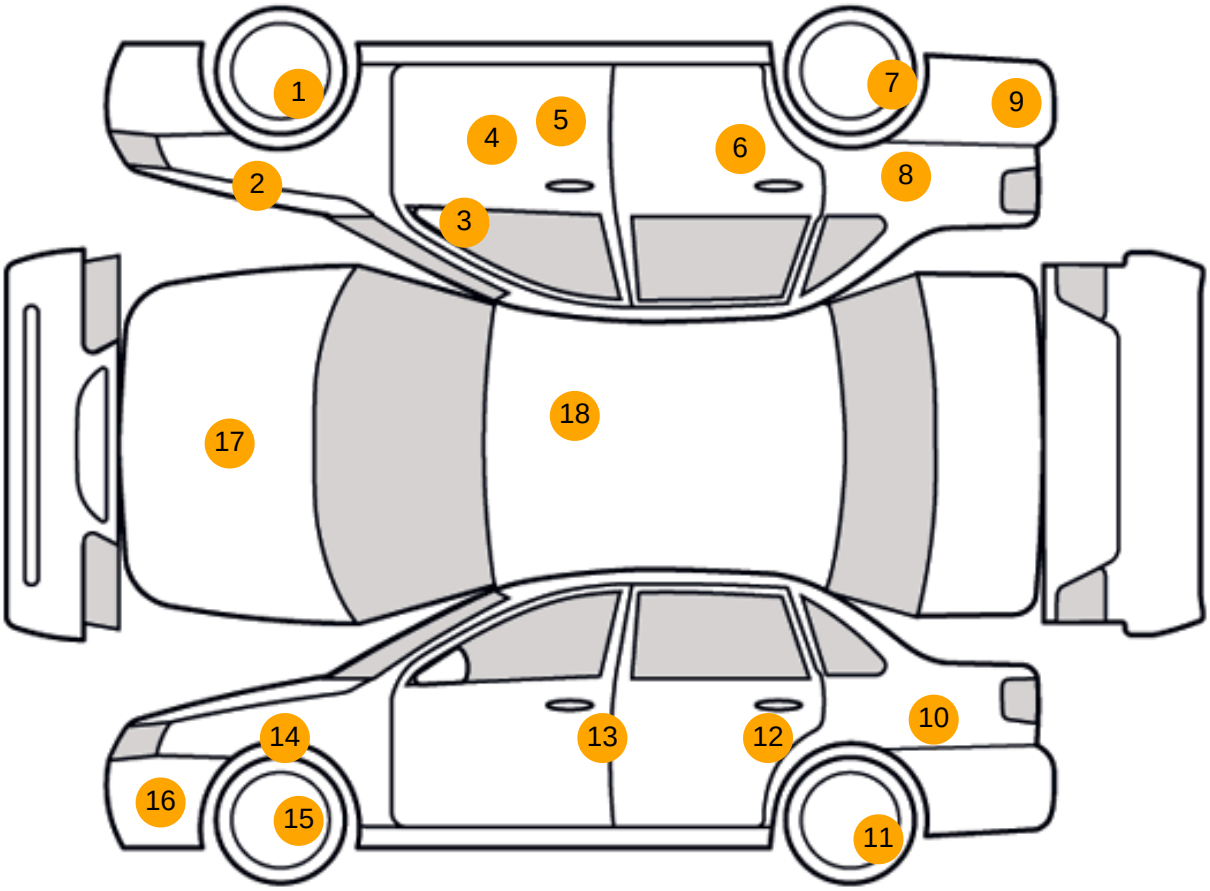
Damage Photos

1: Wheel osf
Scratched
Over 50mm

2: Wing osf
Poor Previous Repair
Poor Paint

3: Door Mirror Assy osf
Scratched (Painted)
UpTo 25mm Thru Paint

4: Door osf
Scratched
UpTo 25mm Thru Paint

5: Door osf
Dented
Between 10mm + 30mm

6: Door osr
Chipped
1 To 5

7: Wheel osr
Scratched
Over 50mm

8: Qtr Panel osr
Chipped
1 To 5

9: Bumper Rear
Poor Previous Repair
Poor Paint

10: Qtr Panel nsr
Dented
With Paint Damage

11: Wheel nsr
Scratched
Over 50mm

12: Door nsr
Chipped
1 To 5

13: Door nsf
Chipped
Edge Chip

14: Wing nsf
Scratched
UpTo 25mm Thru Paint

15: Wheel nsf
Scratched
Over 50mm

16: Bumper Front
Scratched
Over 100mm Thru Paint

17: Bonnet
Chipped
1 To 5

18: Roof
Poor Previous Repair
Paint Flake

19: Seat Base Cover osf
Torn
Over 3mm
