VEHICLE INSPECTION REPORT

ND70OVR

Audi E-Tron 230kW 50 Quattro 71kWh Technik 5dr Auto

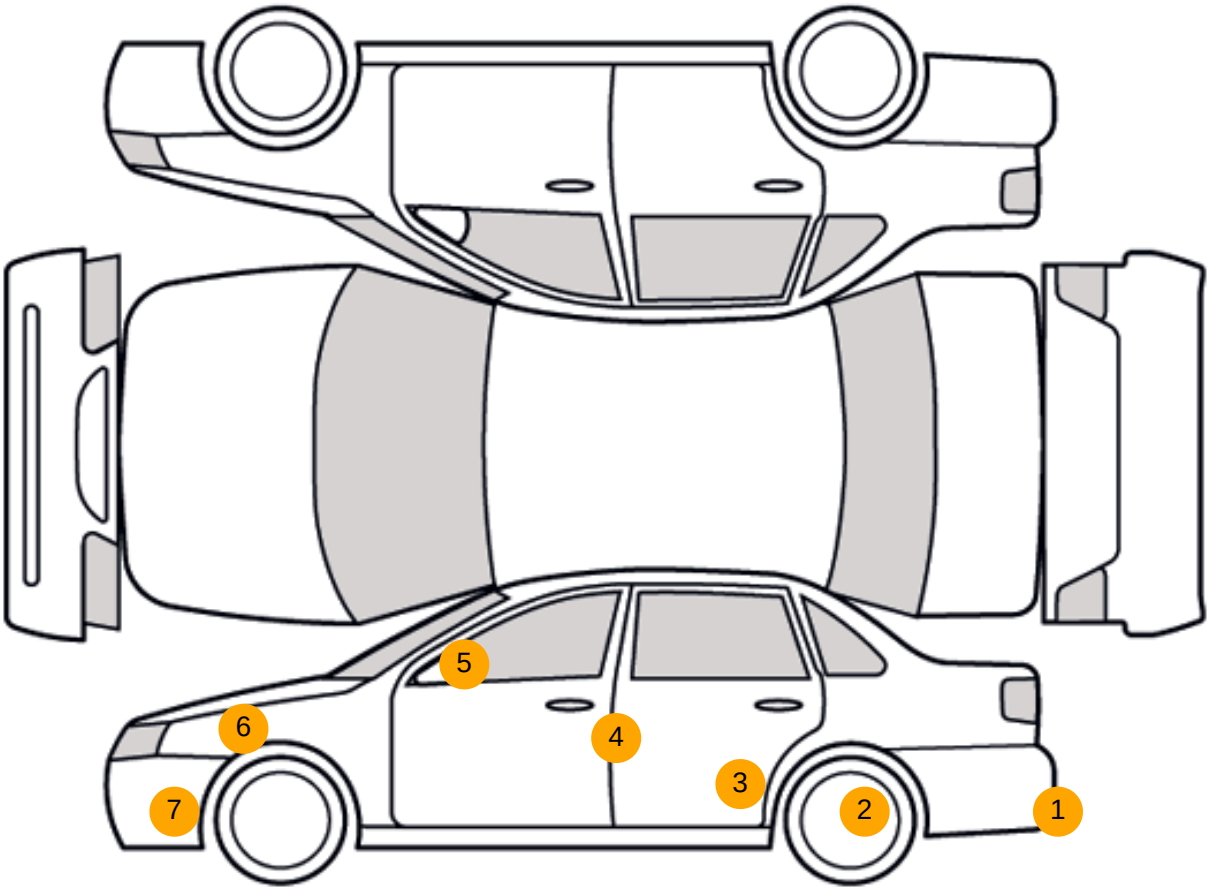
1: Bumper Rear
Scratched
25 to 100mm Thru Paint

2: Wheel nsr
Scratched
Over 50mm

3: Door nsr
Scratched
UpTo 25mm Thru Paint

4: Door nsf
Chipped
1 To 5

5: Door Mirror Assy nsf
Scratched (Painted)
Over 25mm Thru Paint

6: Wing nsf
Chipped
1 To 5

7: Bumper Front
Scratched
25 to 100mm Thru Paint

8: Tyre osf
Damaged
Replace
