VEHICLE INSPECTION REPORT

AV70XDY

Audi A4 35 TFSI Black Edition 5dr S Tronic

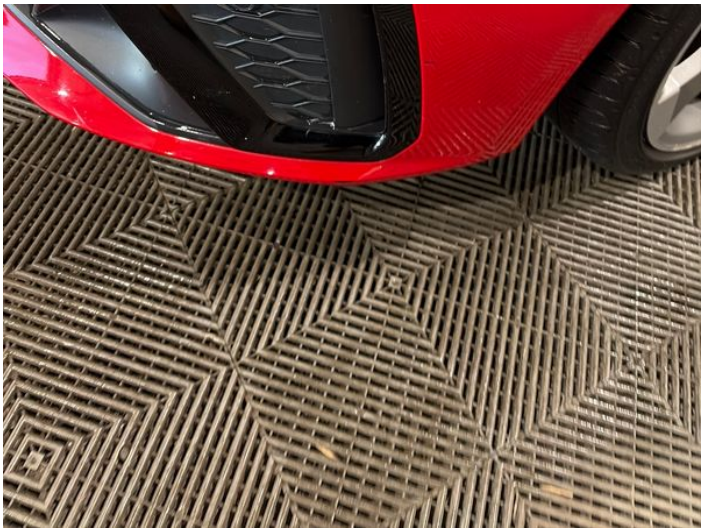
Damage Photos

1: Tyre nsf
Damaged
Replace

2: Bonnet
Chipped
Multiple Chips

3: Bumper Front
Scratched
25 to 100mm Thru Paint

4: Bumper Front
Scratched
25 to 100mm Thru Paint

5: Wheel nsf
Scratched
Over 50mm

6: Wing nsf
Chipped
1 To 5

7: Door nsf
Chipped
Edge Chip

8: Door nsr
Dented
Over 30mm

9: Wheel nsr
Scratched
Over 50mm

10: Wheel osr
Corroded
Light

11: Door osr
Chipped
Edge Chip

12: Door osf
Chipped
Edge Chip

13: Wing osf
Chipped
1 To 5

14: Wheel osf
Scratched
Over 50mm

15: A Post os
Scratched
Over 25mm Thru Paint

16: Roof
Chipped
Edge Chip
