VEHICLE INSPECTION REPORT

GF66LMM

Nissan Qashqai 1.2 DiG-T N-Connecta 5dr

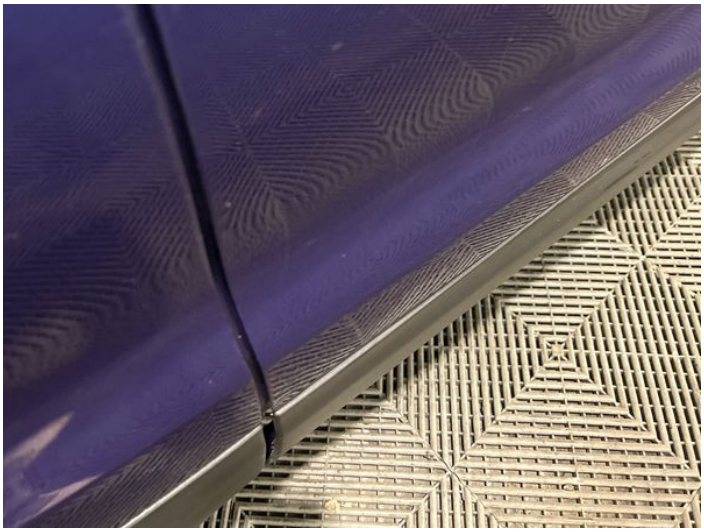
1: Wheel nsf
Scratched
Over 50mm

2: Wing osf
Chipped
1 To 5

3: Door osf
Chipped
Edge Chip

4: Door osf
Chipped
1 To 5

5: Door osr
Scratched
Over 25mm Thru Paint

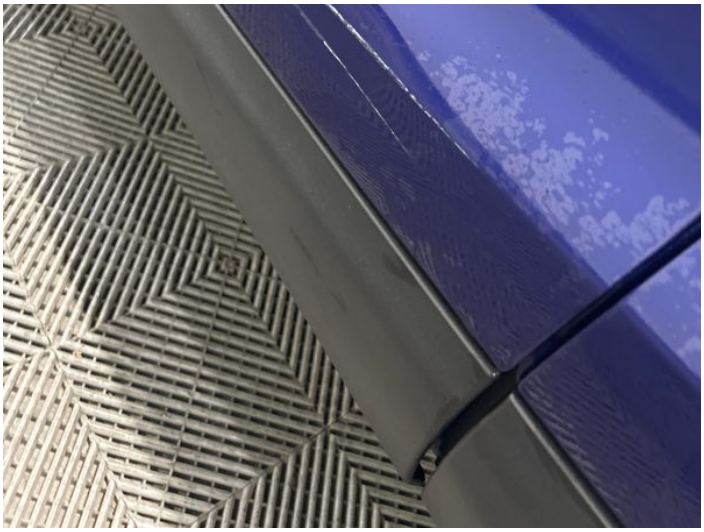
6: Qtr Panel osr
Dented
With Paint Damage

7: Qtr Panel nsr
Dented
Over 30mm

8: Door nsr
Dented
With Paint Damage

9: Door nsf
Scratched
Over 25mm Thru Paint

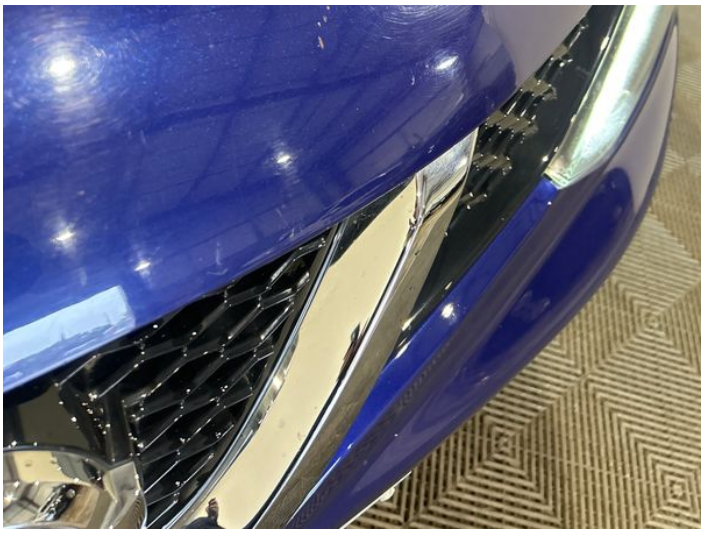
10: Bumper Front
Chipped
Multiple Chips

11: Bonnet
Chipped
Multiple Chips

12: Screen Front
Chipped
UpTo 10mm

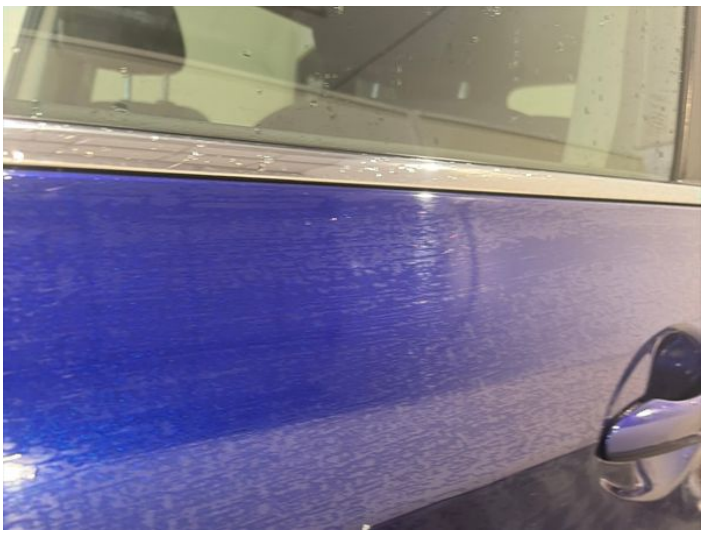
14: Door nsf
Dented
Between 10mm + 30mm
