VEHICLE INSPECTION REPORT

GV71MWC

Vauxhall Astra 1.2 Turbo 145 Griffin Edition 5dr

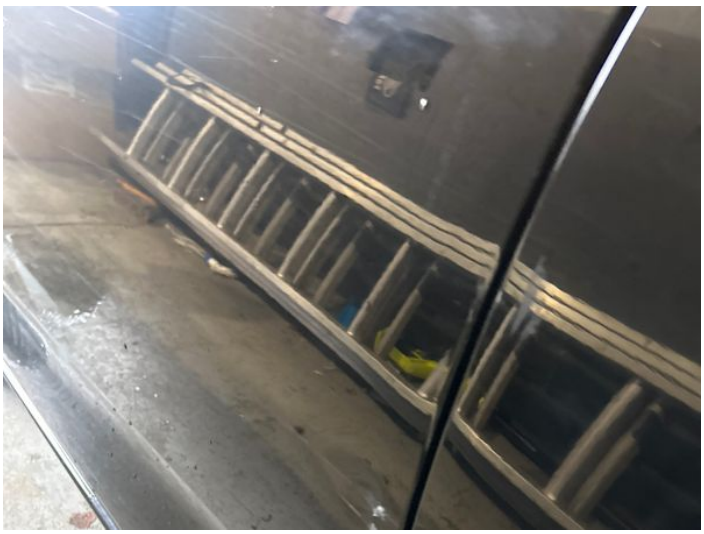
Damage Photos

1: Wheel osf
Scratched
Over 50mm

2: Wing osf
Dented
Between 10mm + 30mm

3: Door Mirror Assy osf
Missing
Replace

4: Door osf
Chipped
Edge Chip

5: Door osr
Scratched
UpTo 25mm Thru Paint

6: Door osr
Chipped
1 To 5

7: Wheel osr
Scratched
Over 50mm

8: Qtr Panel osr
Scratched
Over 25mm Thru Paint

9: Bumper Rear
Cracked
Over 25mm

10: Qtr Panel nsr
Dented
With Paint Damage

11: Wheel nsr
Scratched
Over 50mm

12: Door nsr
Dented
With Paint Damage

13: Door nsf
Dented
With Paint Damage

14: Sill ns
Scratched
UpTo 25mm Thru Paint

15: Wheel nsf
Scratched
Over 50mm

16: Wing nsf
Chipped
Multiple Chips

17: Bumper Front
Scratched
Over 100mm Thru Paint

18: Bonnet
Chipped
1 To 5

19: Screen Front
Chipped
UpTo 10mm
