VEHICLE INSPECTION REPORT

LK21FGZ

Skoda Kodiaq 1.5 TSI SE Drive 5dr DSG [7 Seat]

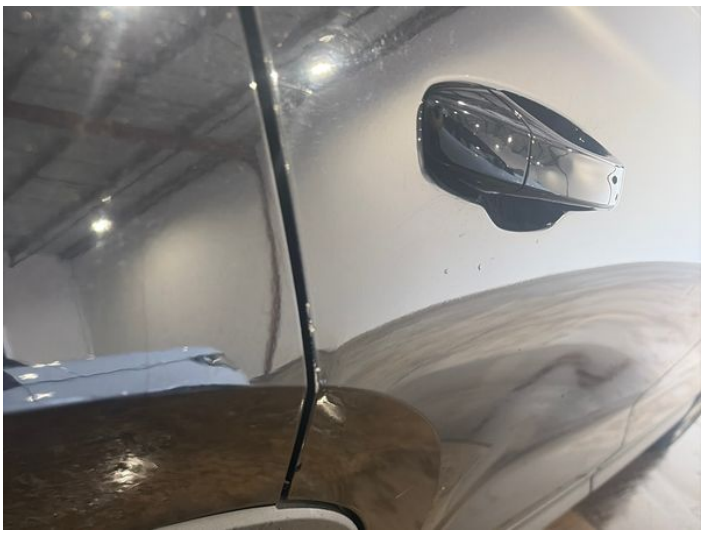
1: Wheel osf
Corroded
Light

2: Wing osf
Dented
With Paint Damage

3: Door osr
Scratched
UpTo 25mm Thru Paint
