VEHICLE INSPECTION REPORT

GU64PFY

Kia Soul 1.6 CRDi Shaker 5dr

nama GRADE 4

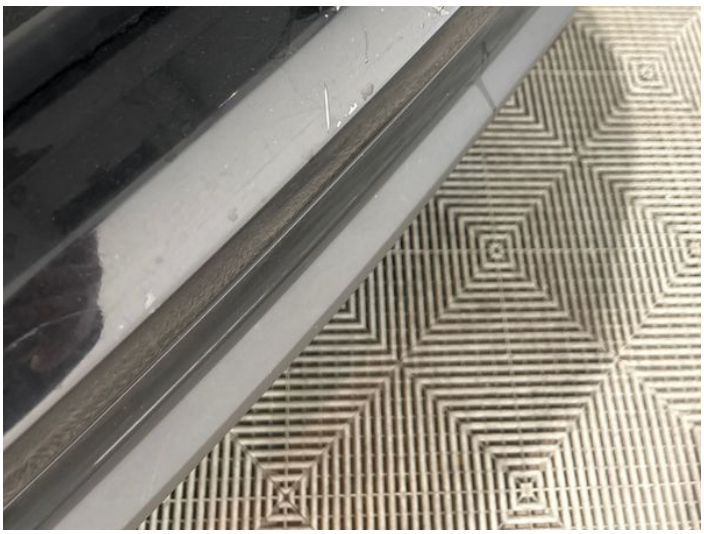
1: Wheel osf
Corroded
Light

2: Wing osf
Chipped
1 To 5

3: Door osf
Dented
With Paint Damage

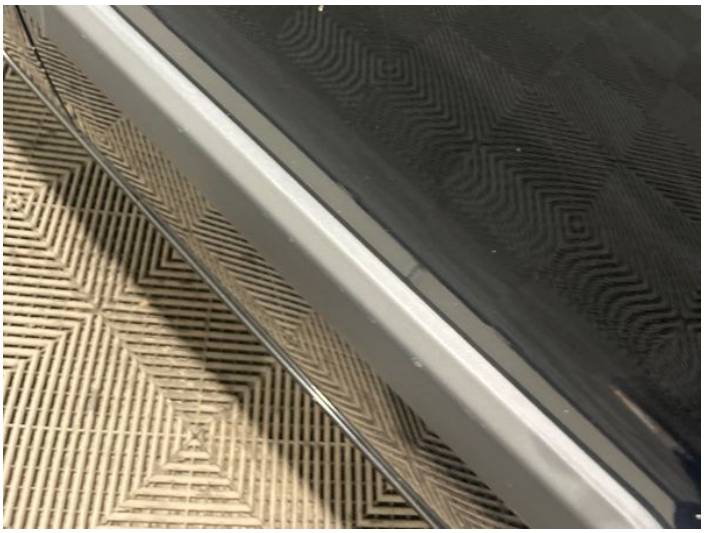
4: Door osr
Dented
With Paint Damage

5: Qtr Panel osr
Dented
With Paint Damage

6: Wheel osr
Corroded
Light

7: Bumper Rear
Scratched
25 to 100mm Thru Paint

8: Boot Lid
Chipped
1 To 5

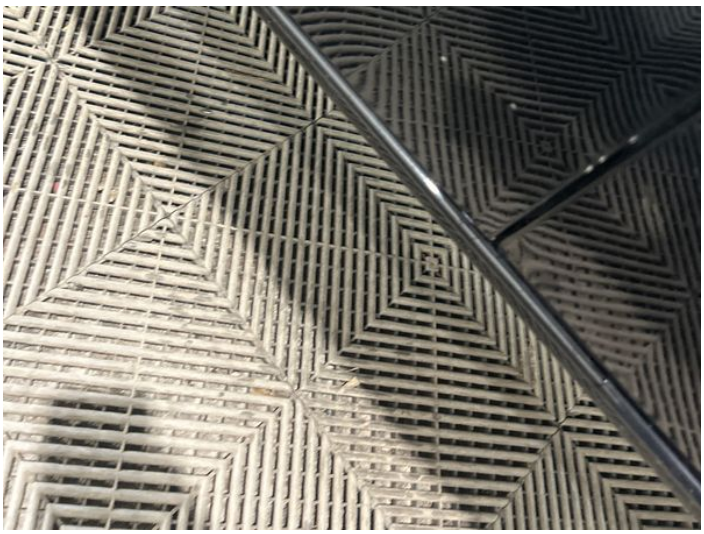
9: Qtr Panel nsr
Chipped
1 To 5

10: Wheel nsr
Corroded
Light

11: Door nsr
Chipped
Edge Chip

12: Door nsr
Chipped
1 To 5
