VEHICLE INSPECTION REPORT

CV18GZJ

Vauxhall Astra 1.0T ecoTEC Tech Line Nav 5dr

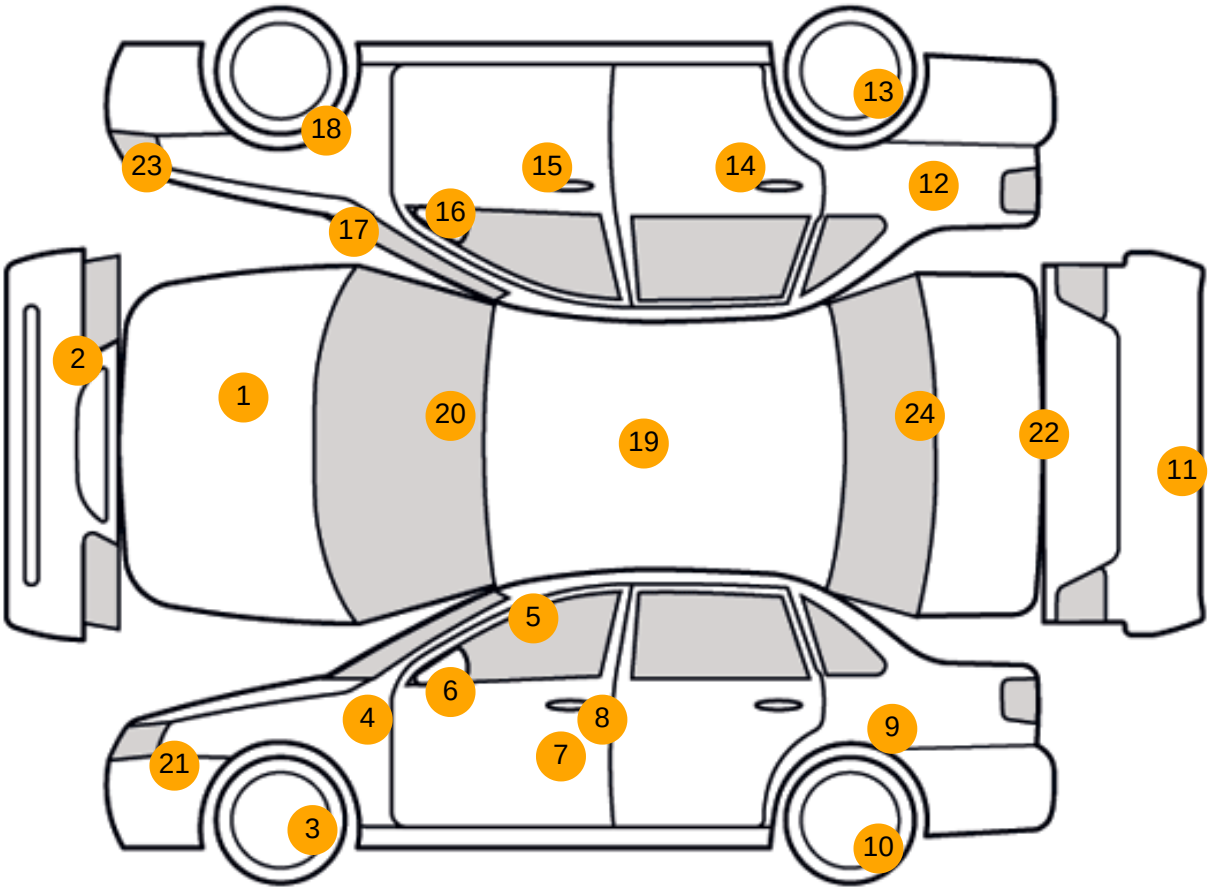
Damage Photos

1: Bonnet
Poor Previous Repair
Paint Flake

2: Bumper Front
Scratched
Over 100mm Thru Paint

3: Wheel nsf
Scratched
Over 50mm

4: Wing nsf
Dented
Over 30mm

5: A Post ns
Dented
With Paint Damage

6: Door Mirror Assy nsf
Scratched (Painted)
Over 25mm Thru Paint

7: Door nsf
Chipped
1 To 5

8: Door nsf
Dented
Between 10mm + 30mm

9: Qtr Panel nsr
Dented
With Paint Damage

10: Wheel nsr
Scratched
Up To 50mm

11: Bumper Rear
Poor Previous Repair
Paint Flake

12: Qtr Panel osr
Poor Previous Repair
Poor Paint

13: Wheel osr
Scratched
Over 50mm

14: Door osr
Poor Previous Repair
Poor Paint

15: Door osf
Dented
Over 30mm

16: Door Mirror Assy osf
Scratched (Painted)
Over 25mm Thru Paint

17: Wing osf
Chipped
Multiple Chips

18: Wheel osf
Scratched
Over 50mm

19: Roof
Poor Previous Repair
Paint Flake

20: Screen Front
Chipped
Over 10mm

21: Other
N/A
N/A
Scratched

22: Boot Lid
Chipped
1 To 5

23: Other
N/A
N/A
Osf headlight scratched and chipped

24: Screen Rear
Scratched
Over 30mm
