VEHICLE INSPECTION REPORT

NA15NKH

Nissan Qashqai 1.5 dCi N-Tec+ 5dr

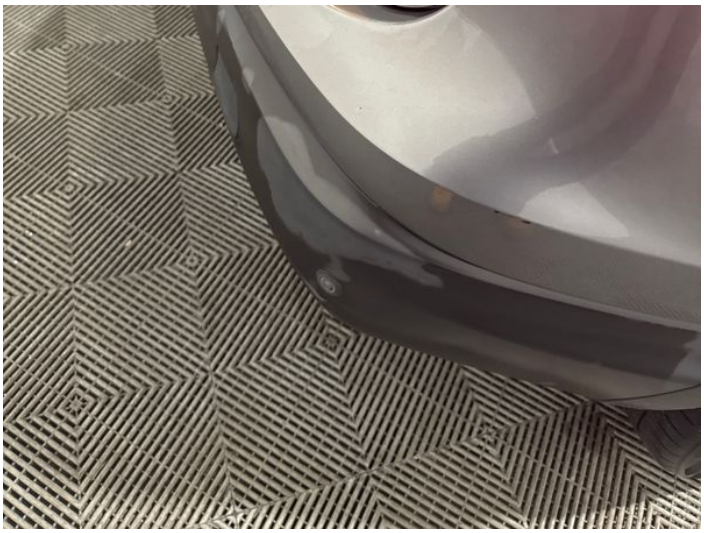
1: Fascia Trim
Missing
Replace

2: Bonnet
Chipped
1 To 5

3: Bumper Front
Chipped
Multiple Chips

4: Wheel nsf
Scratched
Over 50mm

5: Door nsf
Dented
With Paint Damage

6: Door Mirror Assy nsf
Broken
Replace

7: Door nsr
Dented
With Paint Damage

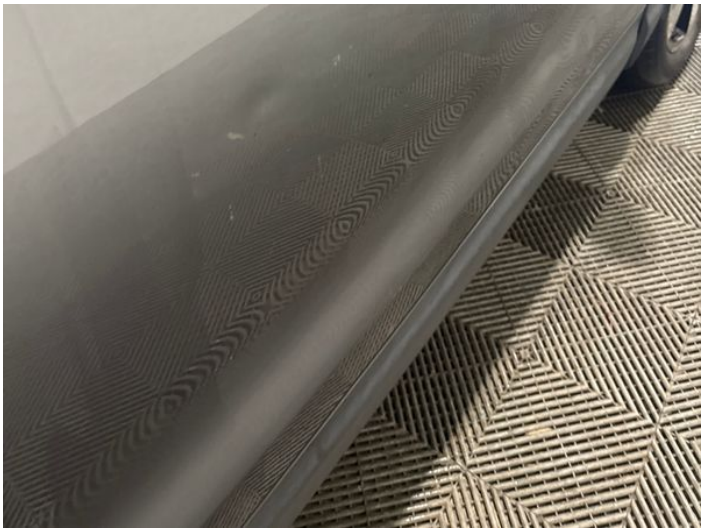
8: Door Moulding nsr
Scuffed (Unpainted)
Over 100mm

9: Wheel nsr
Scratched
Over 50mm

10: Qtr Panel nsr
Scratched
UpTo 25mm Thru Paint

11: Bumper Rear
Scratched
25 to 100mm Thru Paint

12: Wheel osr
Corroded
Light
