VEHICLE INSPECTION REPORT

KY16DDL

Seat Ibiza 1.2 TSI 90 Connect 5dr

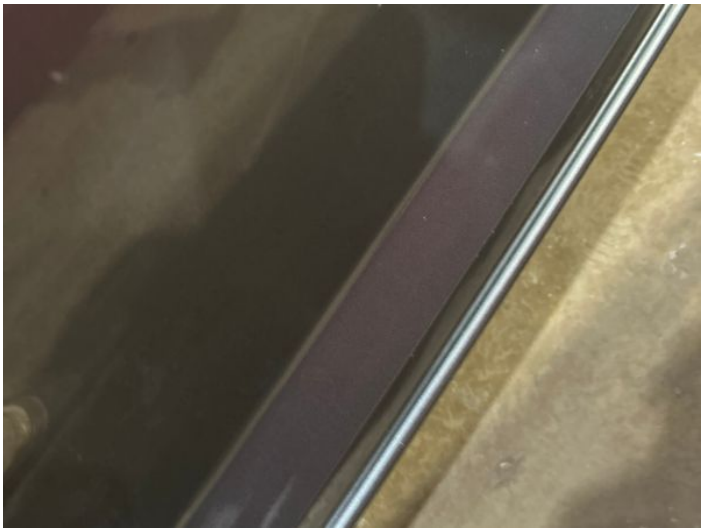
1: Wheel osf
Corroded
Light

2: Wing osf
Poor Previous Repair
Poor Paint

3: Door osf
Chipped
Edge Chip

4: Door osf
Chipped
1 To 5

5: Door osr
Chipped
1 To 5

6: Door osr
Chipped
Edge Chip

7: Wheel osr
Corroded
Light

8: Qtr Panel osr
Chipped
1 To 5

9: Bumper Rear
Chipped
1 To 5

10: Qtr Panel nsr
Dented
With Paint Damage

11: Wheel nsr
Corroded
Light

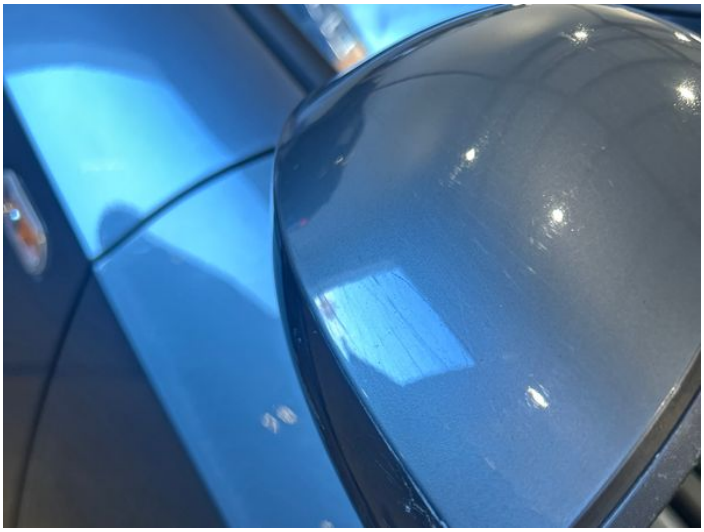
12: Door nsr
Scratched
Over 25mm Thru Paint

13: Door nsf
Dented
With Paint Damage

14: A Post ns
Dented
With Paint Damage

15: Door Mirror Assy nsf
Scratched (Painted)
UpTo 25mm Thru Paint

16: Wheel nsf
Corroded
Light

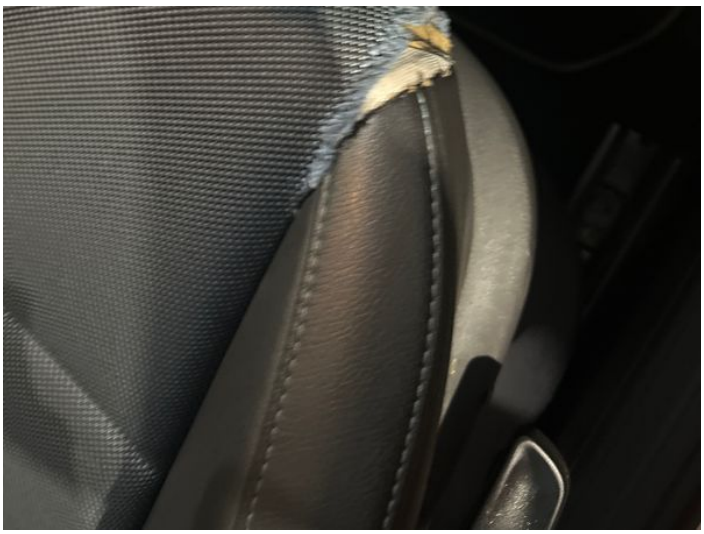
17: Wing nsf
Poor Previous Repair
Poor Paint

18: Bumper Front
Poor Previous Repair
Poor Paint

19: Bonnet
Poor Previous Repair
Poor Paint

20: Seat Base Cover osf
Holed
Over 3mm
