# VEHICLE INSPECTION REPORT

**GM15WZG**

## Kia Rio 1.25 SR7 5dr

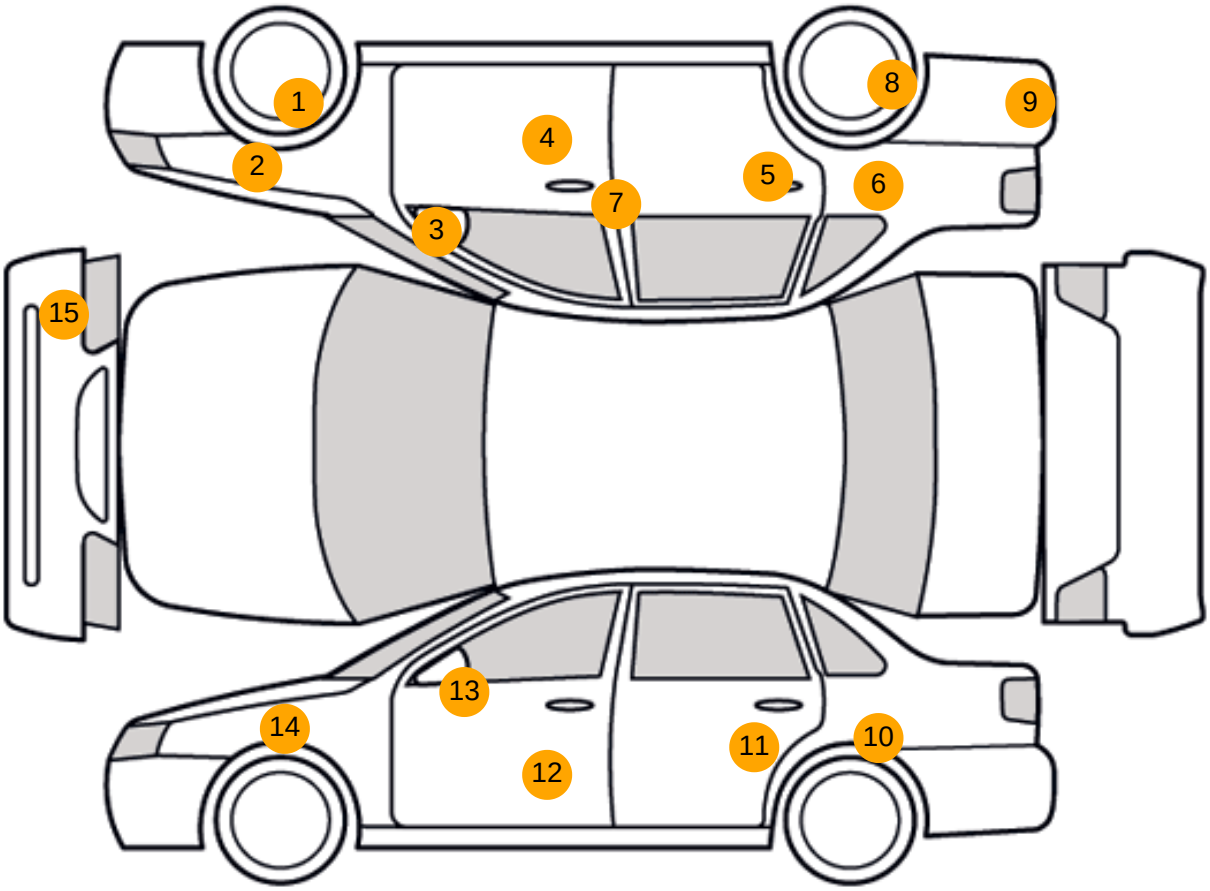
# Condition Check

1: Carpets Front
Holed
Over 3mm

2: Wheel osf
Scratched
Up To 50mm

3: Wing osf
Chipped
1 To 5

4: Door Mirror Assy osf
Scratched (Painted)
Over 25mm Thru Paint

5: Door osf
Chipped
1 To 5

6: Door osr
Dented
With Paint Damage

7: Qtr Panel osr
Dented
With Paint Damage

8: Handle Outer osf
Scratched (Painted)
Over 25mm Thru Paint

9: Wheel osr
Scratched
Up To 50mm

10: Bumper Rear
Scratched
Over 100mm Thru Paint

11: Qtr Panel nsr
Dented
With Paint Damage

12: Door nsr
Dented
With Paint Damage

13: Door nsf
Dented
With Paint Damage

14: Door Mirror Assy nsf
Scratched (Painted)
Over 25mm Thru Paint

15: Wing nsf
Scratched
Over 25mm Thru Paint

16: Bumper Front
Scratched
Over 100mm Thru Paint
