VEHICLE INSPECTION REPORT

GU65FFX

Subaru Outback 2.5i SE Premium 5dr Lineartronic

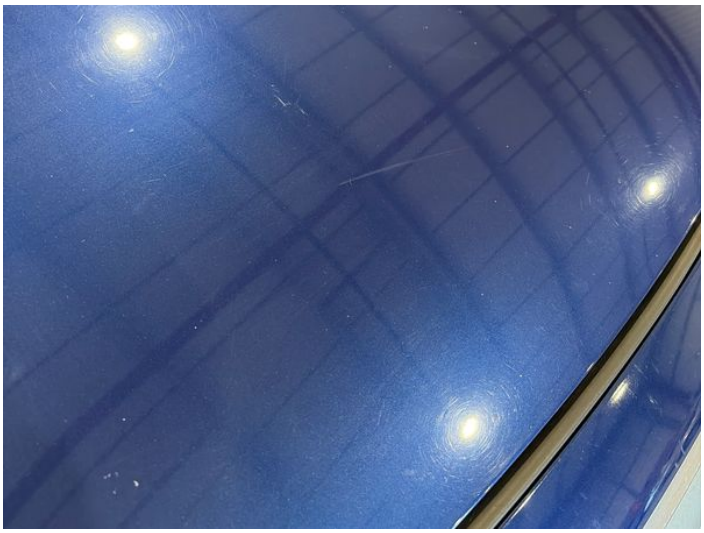
1: Bonnet
Scratched
Over 25mm Thru Paint

2: Bumper Front
Poor Previous Repair
Paint Flake

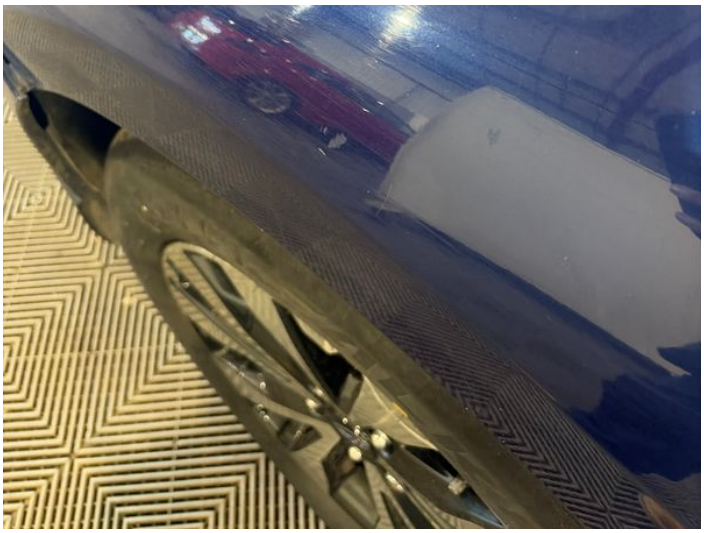
3: Grille Front
Broken
Replace

4: Bumper Front
Insecure
Action Required

5: Wheel nsf
Scratched
Over 50mm

6: Wing nsf
Scratched
Over 25mm Thru Paint

7: A Post ns
Chipped
1 To 5

8: Door Mirror Assy nsf
Scratched (Painted)
UpTo 25mm Thru Paint

9: Door nsf
Dented
With Paint Damage

10: Door nsr
Dented
With Paint Damage

11: Wheel nsr
Scratched
Over 50mm

12: Qtr Panel nsr
Scratched
Over 25mm Thru Paint

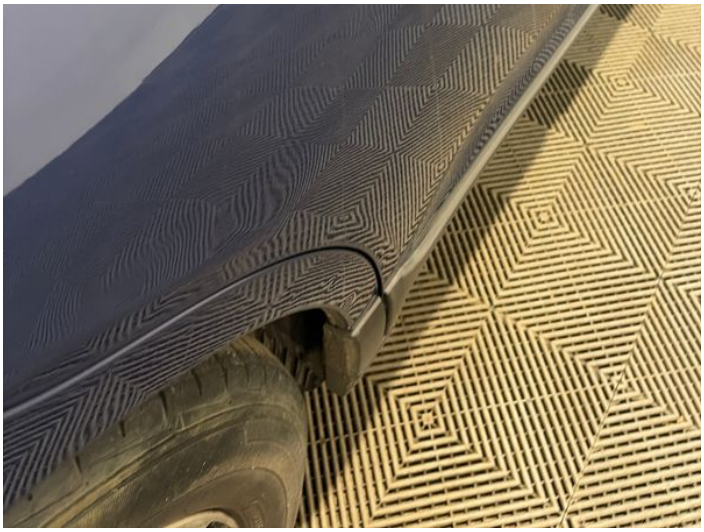
13: Bumper Rear
Dented
With Paint Damage

14: Boot Lid
Scratched
UpTo 25mm Thru Paint

15: Wheel osr
Scratched
Up To 50mm

16: Door osr
Dented
Between 10mm + 30mm

17: Door osr
Scratched
UpTo 25mm Thru Paint

18: Door osf
Scratched
Over 25mm Thru Paint

19: Wheel osf
Scratched
Over 50mm
