VEHICLE INSPECTION REPORT

WU21YLF

Toyota Prius 1.8 VVTi Business Edition Plus 5dr CVT AWD

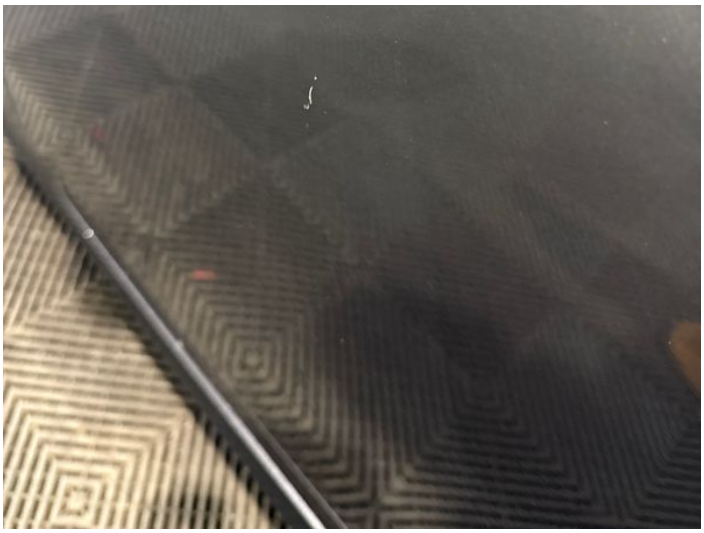
Damage Photos

1: Wing osf
Chipped
1 To 5

2: Door osf
Chipped
Edge Chip

3: Door nsr
Chipped
1 To 5

4: Bumper Front
Chipped
1 To 5

5: Bonnet
Chipped
1 To 5

6: Door Mirror Assy osf
Scratched (Painted)
UpTo 25mm Thru Paint

7: Door osf
Scratched
Over 25mm Thru Paint

8: Door osr
Dented
With Paint Damage

9: Qtr Panel osr
Chipped
1 To 5

10: Qtr Panel nsr
Scratched
UpTo 25mm Thru Paint

11: Door nsr
Dented
Between 10mm + 30mm

12: Door nsf
Scratched
UpTo 25mm Thru Paint

13: Wing nsf
Scratched
Over 25mm Thru Paint
