VEHICLE INSPECTION REPORT

RK67KXO

Dacia Duster 1.2 TCe 125 Prestige 5dr

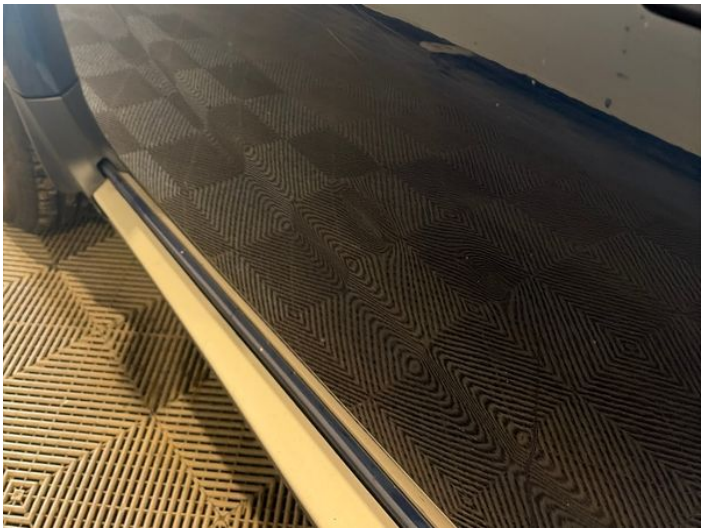
Damage Photos

1: Wing osf
Scratched
UpTo 25mm Thru Paint

2: Door Mirror Assy osf
Scratched (Painted)
Over 25mm Thru Paint

3: Door osf
Scratched
Over 25mm Thru Paint

4: Qtr Panel osr
Chipped
1 To 5

5: Bumper Rear
Scratched
Over 100mm Thru Paint

6: Boot Lid
Scratched
UpTo 25mm Thru Paint

7: Qtr Panel nsr
Dented
With Paint Damage

8: Door nsr
Scratched
Over 25mm Thru Paint

9: Door nsf
Dented
With Paint Damage

10: Door Mirror Assy nsf
Scratched (Painted)
Over 25mm Thru Paint

11: Wing nsf
Scratched
Over 25mm Thru Paint

12: Bumper Front
Scratched
Over 100mm Thru Paint

13: Bonnet
Scratched
Over 25mm Thru Paint

14: Lamp osr
Broken
Replace

15: Door osr
Dented
Over 30mm
