VEHICLE INSPECTION REPORT

FH63XRC

Vauxhall Corsa 1.4 SRi 3dr [AC]

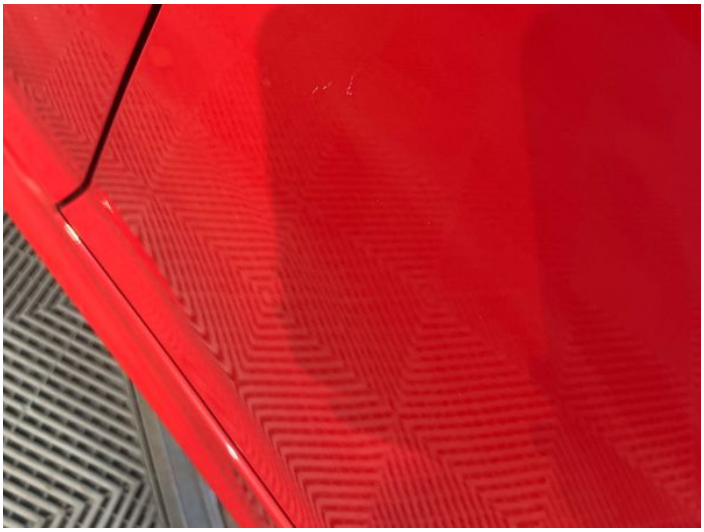
1: Wheel osf
Scratched
Over 50mm

2: Wing osf
Chipped
1 To 5

3: Door osf
Chipped
1 To 5

4: Door osf
Chipped
Edge Chip

5: Wheel osr
Scratched
Over 50mm

6: Bumper Rear
Chipped
1 To 5

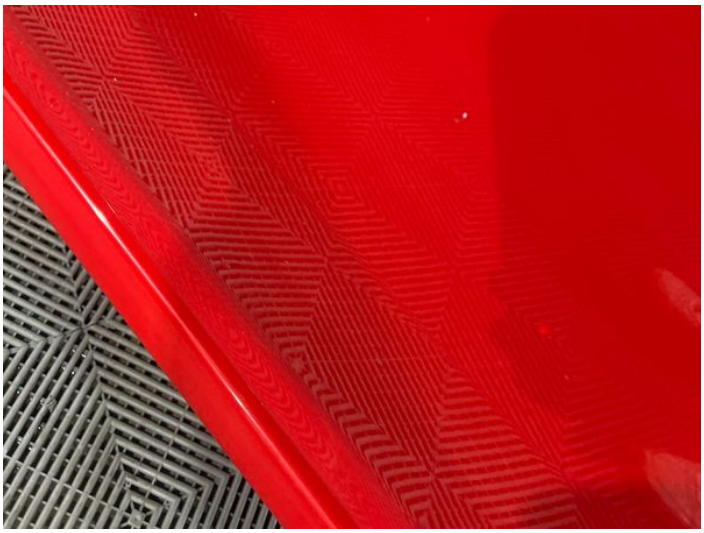
7: Boot Lid
Dented
2 Or Less UpTo 10mm

8: Wheel nsr
Scratched
Over 50mm

9: Qtr Panel nsr
Scratched
UpTo 25mm Thru Paint

10: Qtr Panel nsr
Chipped
1 To 5
