VEHICLE INSPECTION REPORT

GY67XRD

Audi A5 2.0 TFSI Quattro S Line 2dr S Tronic

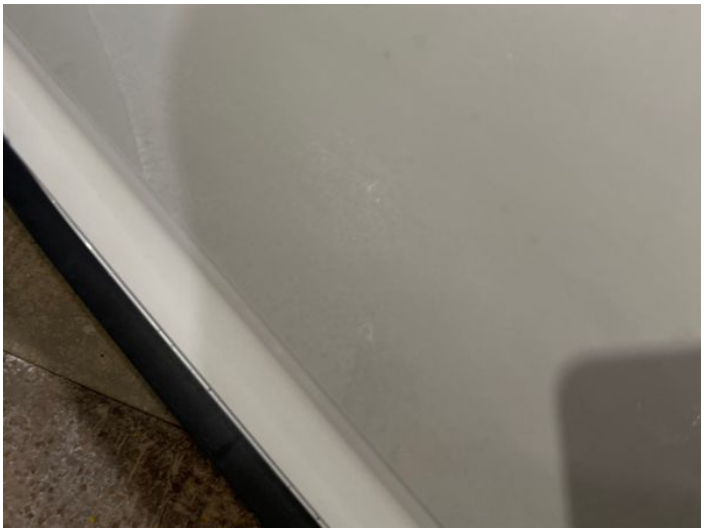
1: Wheel osf
Scratched
Over 50mm

2: Sill Panel Trim os
Scratched (Painted)
Over 25mm Thru Paint

3: Door osf
Dented
Between 10mm + 30mm

4: Door osf
Chipped
1 To 5

5: Door osf
Chipped
Edge Chip

6: Qtr Panel osr
Dented
With Paint Damage

7: Wheel osr
Scratched
Over 50mm

8: Bumper Rear
Poor Previous Repair
Paint Flake

9: Qtr Panel nsr
Dented
With Paint Damage

10: Wheel nsr
Scratched
Over 50mm

11: Sill Panel Trim ns
Broken
Replace

12: Door nsf
Dented
With Paint Damage

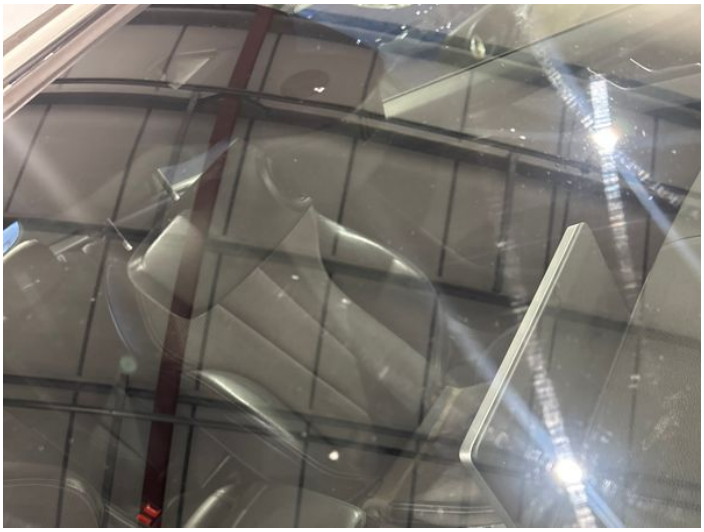
13: Wing nsf
Dented
With Paint Damage

14: Wheel nsf
Scratched
Over 50mm

15: Bonnet
Chipped
1 To 5

16: Screen Front
Chipped
UpTo 10mm

17: Door Pad osf
Scuffed
UpTo 25mm

18: Bumper Front
Cracked
Over 25mm
