VEHICLE INSPECTION REPORT

AK10VFY

Land Rover Freelander 2.2 Td4 HSE 5dr Auto

Condition Check

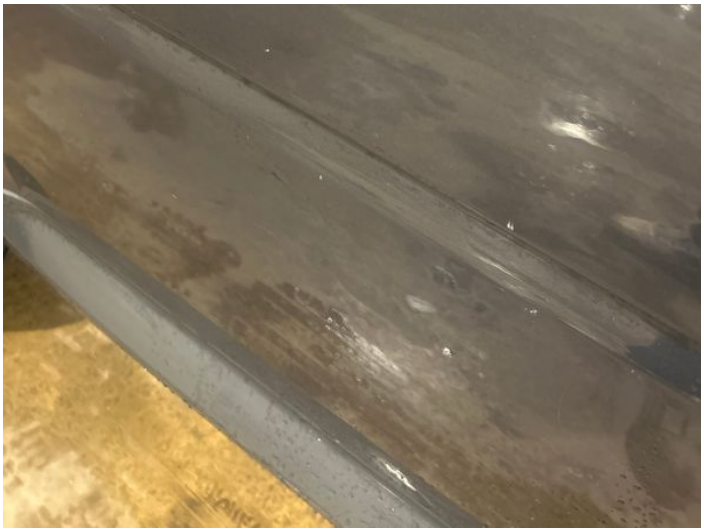
2: Wing osf
Chipped
1 To 5

3: Door osf
Chipped
Multiple Chips
