VEHICLE INSPECTION REPORT

CE12XAD

Ford Focus 1.6 125 Zetec 5dr

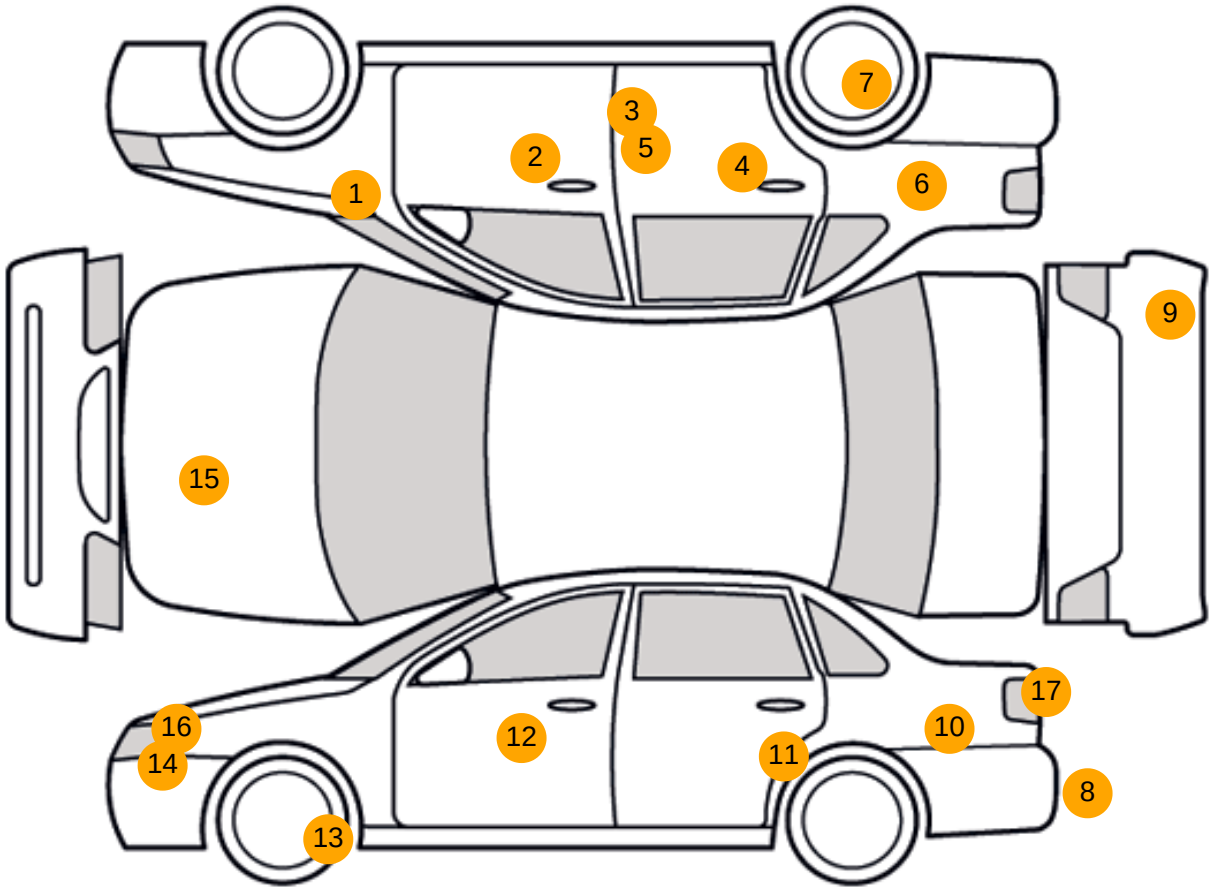
Damage Photos

1: Wing osf
Dented
Over 30mm

2: Door osf
Chipped
1 To 5

3: Door osf
Dented
2 Or Less UpTo 10mm

4: Door osr
Dented
Over 30mm

5: Door osf
Chipped
Edge Chip

6: Qtr Panel osr
Scratched
Over 25mm Thru Paint

7: Wheel osr
Scratched
Over 50mm

8: Bumper Rear
Scratched
Over 100mm Thru Paint

9: Tailgate
Scratched
UpTo 25mm Thru Paint

10: Qtr Panel nsr
Dented
Over 30% Of Panel

11: Door nsr
Dented
With Paint Damage

12: Door nsf
Chipped
1 To 5

13: Wheel nsf
Scratched
Over 50mm

14: Bumper Front
Scratched
Over 100mm Thru Paint

15: Bonnet
Chipped
1 To 5

16: Seat Back Cover osf
Torn
UpTo 3mm

18: Lamp nsr
Broken
Replace
