VEHICLE INSPECTION REPORT

KY62HXW

Mercedes-Benz E Class E250 CDI BlueEFFICIENCY Sport 2dr Tip Auto

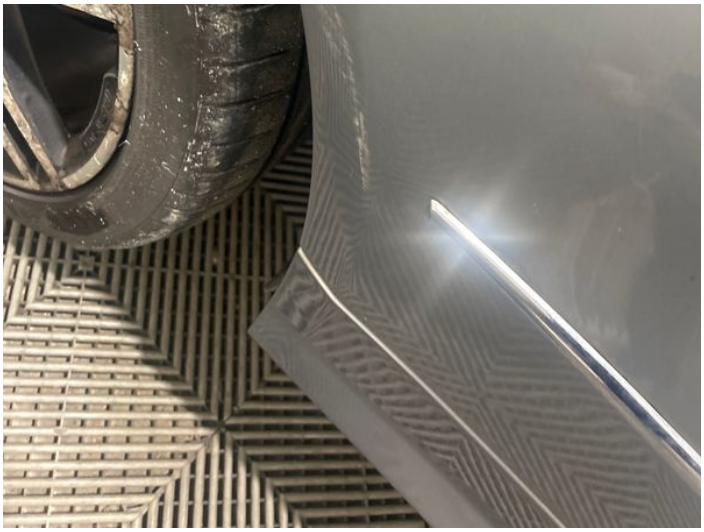
1: Seat Base Cover osf
Scuffed
Over 25mm

2: Wheel osf
Corroded
Light

3: Door osf
Chipped
Edge Chip

4: Qtr Panel osr
Scratched
Over 25mm Thru Paint

5: Wheel osr
Corroded
Light

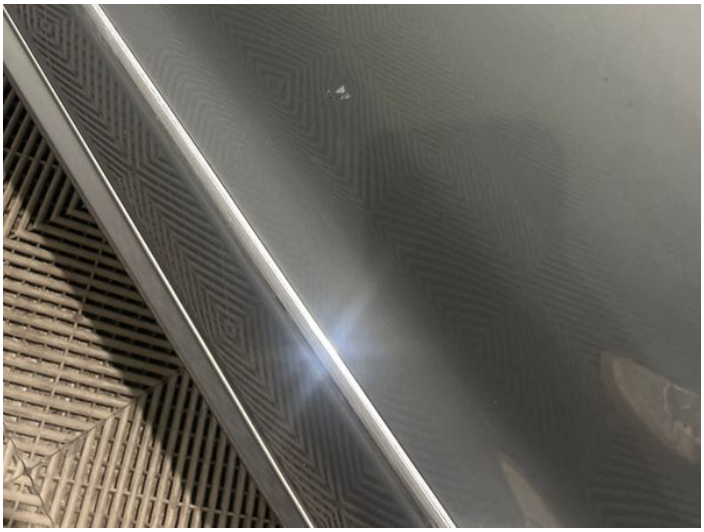
6: Bumper Rear
Poor Previous Repair
Poor Paint

7: Boot Lid
Chipped
1 To 5

8: Wheel nsr
Corroded
Light

9: Door nsf
Chipped
1 To 5

11: Wheel nsf
Corroded
Light

12: Bumper Front
Poor Previous Repair
Paint Flake

13: Bonnet
Chipped
1 To 5

14: A Post os
Chipped
1 To 5

15: Other
N/A
N/A
Front parking sensor missing
