VEHICLE INSPECTION REPORT

MA15XSP

Ford C-Max 1.6 TDCi Zetec 5dr

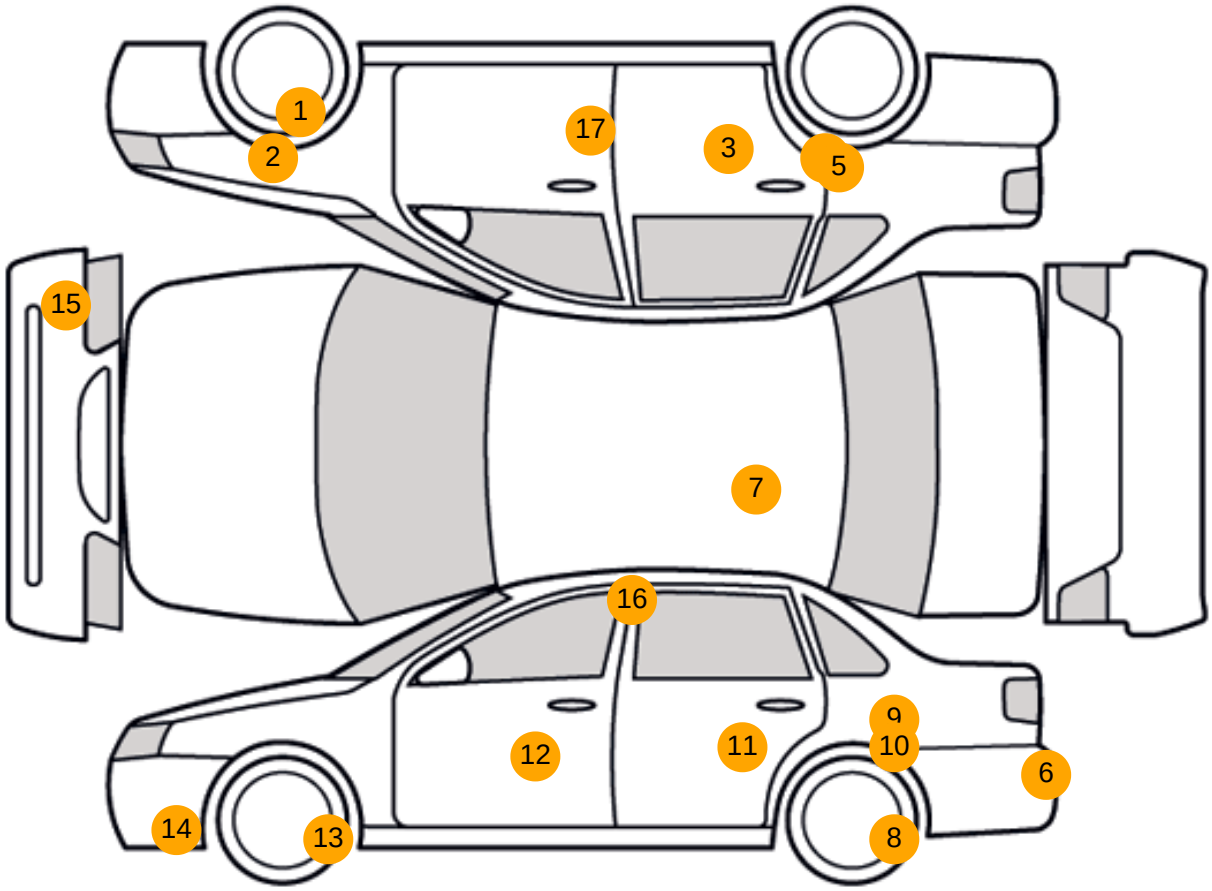
Damage Photos

1: Wheel osf
Scratched
Over 50mm

2: Wing osf
Scratched
Over 25mm Thru Paint

3: Door osr
Chipped
1 To 5

4: Qtr Panel osr
Chipped
1 To 5

5: Qtr Panel osr
Dented
2 Or Less UpTo 10mm

6: Bumper Rear
Chipped
1 To 5

7: Roof
Poor Previous Repair
Paint Flake

8: Wheel nsr
Scratched
Over 50mm

9: Qtr Panel nsr
Dented
Between 10mm + 30mm

10: Qtr Panel nsr
Chipped
1 To 5

11: Door nsr
Chipped
Multiple Chips

12: Door nsf
Dented
Over 30mm

13: Wheel nsf
Scratched
Over 50mm

14: Bumper Front
Scratched
25 to 100mm Thru Paint

15: Bumper Front
Chipped
Multiple Chips

16: B Post ns
Poor Previous Repair
Paint Flake

17: Door osf
Dented
Over 30mm
