VEHICLE INSPECTION REPORT

FV11PMY

Skoda Fabia 1.2 TSI SE 5dr

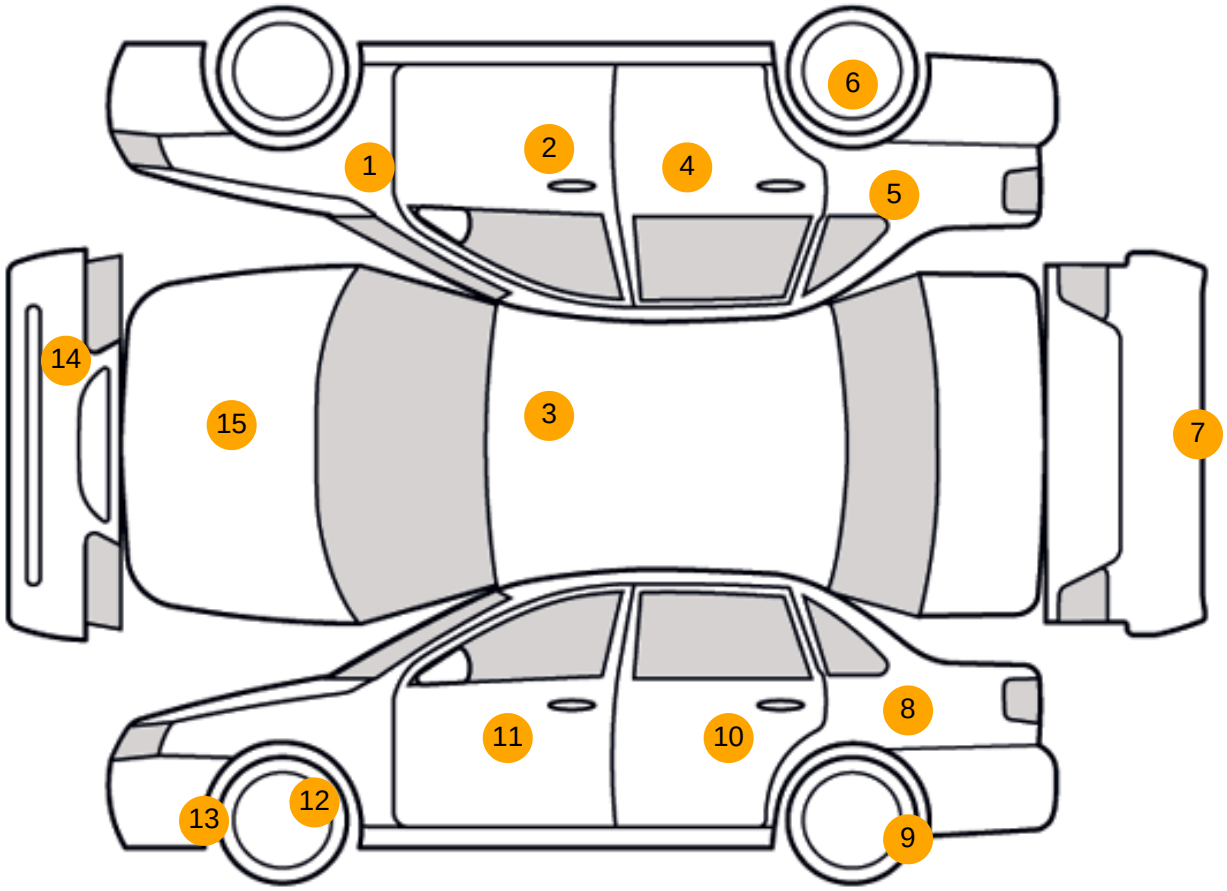
1: Wing osf
Scratched
UpTo 25mm Thru Paint

2: Door osf
Scratched
Over 25mm Thru Paint

3: Roof
Poor Previous Repair
Paint Flake

4: Door osr
Dented
Over 30mm

5: Qtr Panel osr
Chipped
1 To 5

6: Wheel osr
Scratched
Over 50mm

7: Bumper Rear
Poor Previous Repair
Paint Flake

8: Qtr Panel nsr
Scratched
Over 25mm Thru Paint

9: Wheel nsr
Scratched
Up To 50mm

10: Door nsr
Rusted
UpTo 5mm

11: Door nsf
Chipped
Multiple Chips

12: Wheel nsf
Scratched
Over 50mm

13: Bumper Front
Scratched
Over 100mm Thru Paint

14: Bumper Front Moulding
Broken
Replace

15: Bonnet
Chipped
1 To 5
