VEHICLE INSPECTION REPORT

BD14NNW

Audi A4 2.0 TDI 150 S Line 4dr

nama GRADE 4

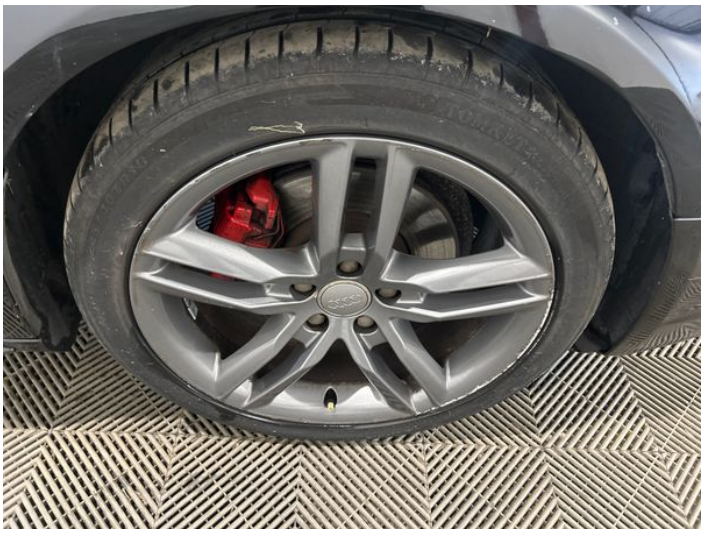
1: Wheel osf
Scratched
Over 50mm

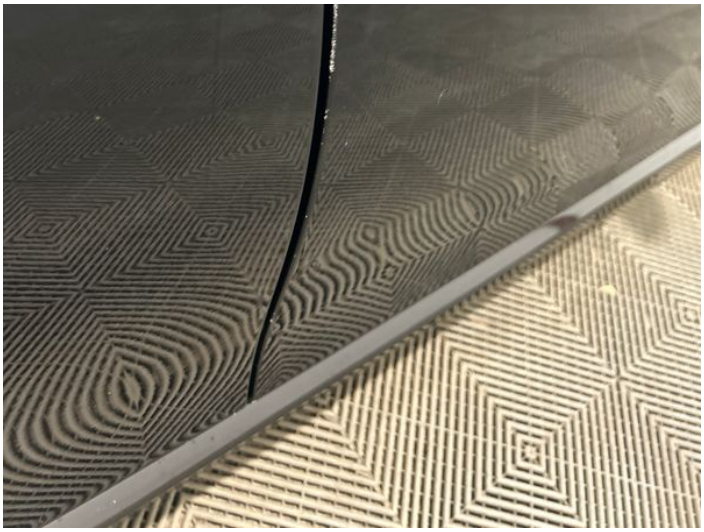
2: Wing osf
Scratched
Over 25mm Thru Paint

3: Door osf
Chipped
Edge Chip

4: Door osf
Dented
2 Or Less UpTo 10mm

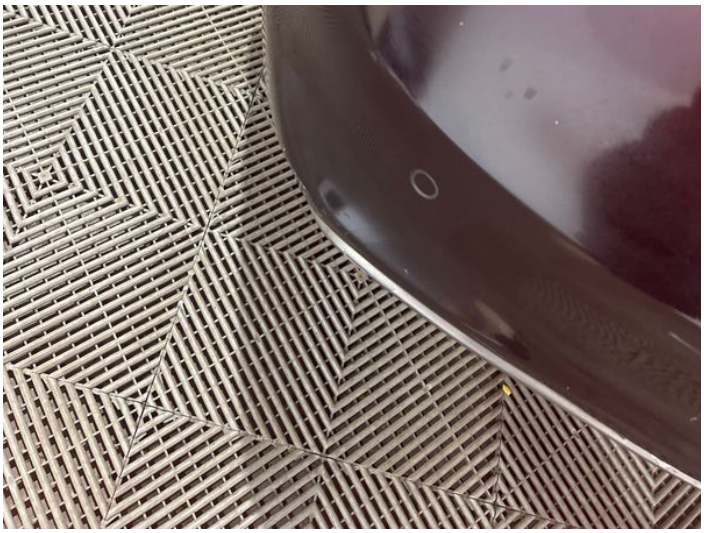
5: Door osr
Chipped
Edge Chip

6: Bumper Rear
Poor Previous Repair
Poor Paint

7: Qtr Panel nsr
Scratched
Over 25mm Thru Paint

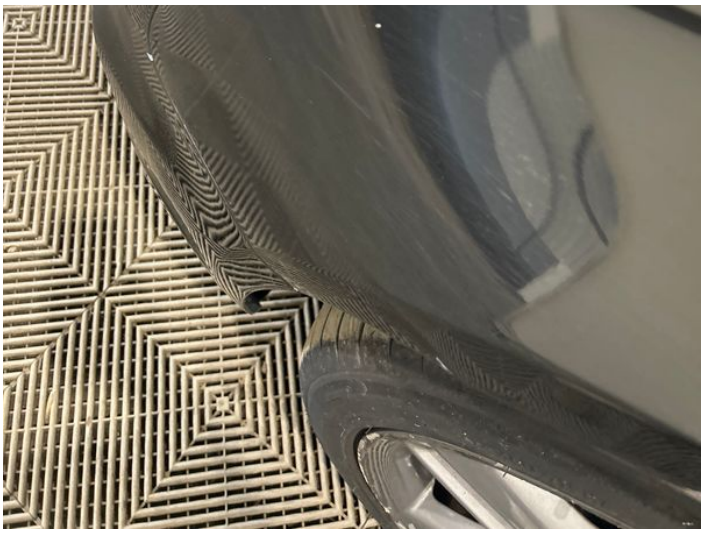
8: Wheel nsr
Scratched
Over 50mm

9: Door nsr
Chipped
1 To 5

10: Wheel nsf
Scratched
Over 50mm

11: Wing nsf
Chipped
1 To 5

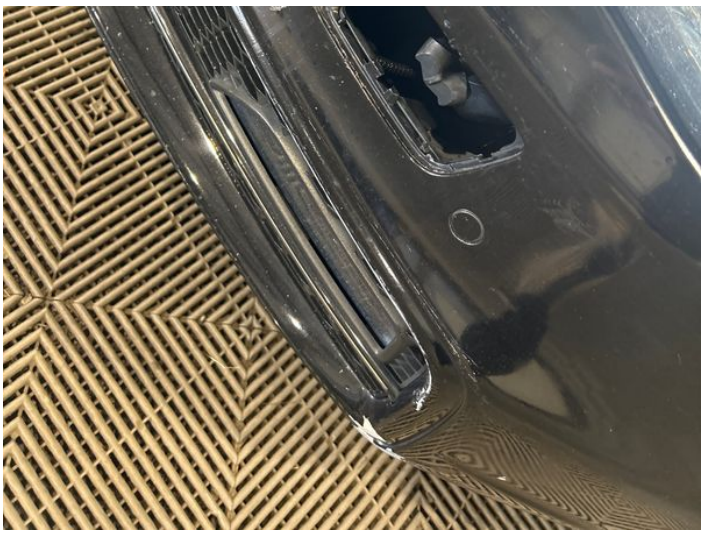
12: Bumper Front
Poor Previous Repair
Paint Flake

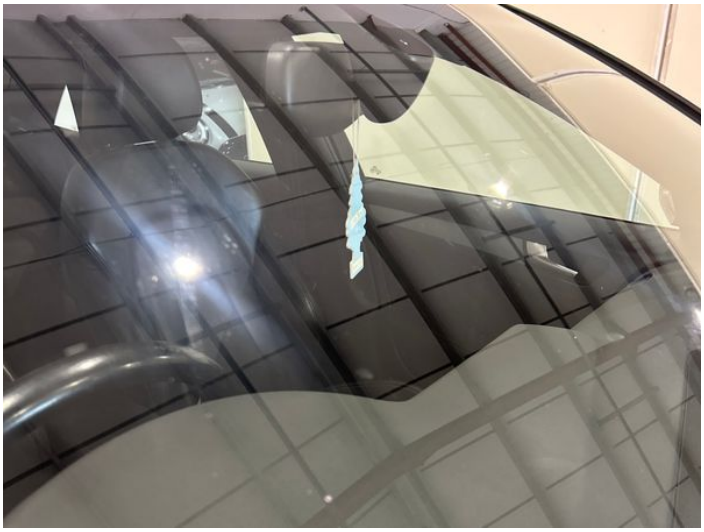
14: Bonnet
Chipped
Multiple Chips

15: Screen Front
Chipped
UpTo 10mm

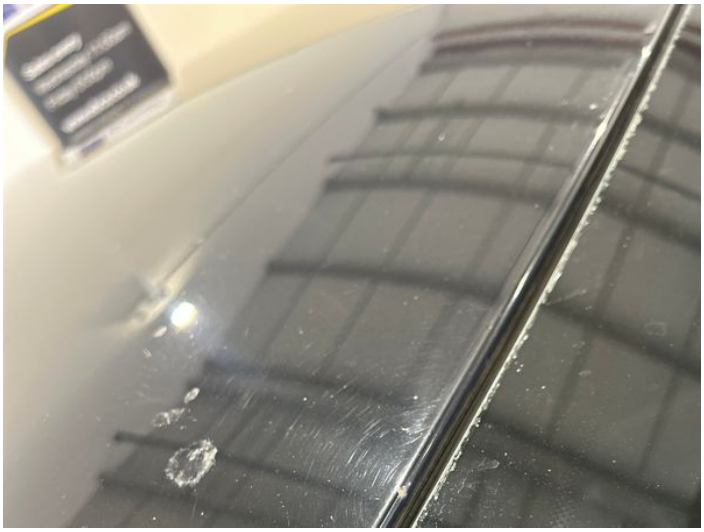
16: Roof
Chipped
1 To 5
