VEHICLE INSPECTION REPORT

HXZ6016

Kia Sportage 1.6T GDi GT-Line 5dr DCT Auto [AWD]

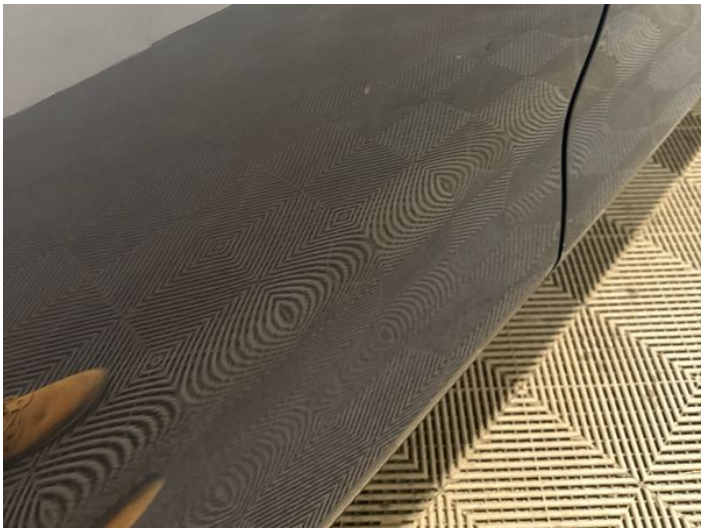
6: Door nsf
Scratched
Over 25mm Thru Paint

7: Door nsr
Scratched
Over 25mm Thru Paint

8: Wheel nsr
Scratched
Over 50mm

9: Door nsr
Dented
Between 10mm + 30mm

10: Qtr Panel nsr
Chipped
1 To 5

11: Boot Lid
Scratched
UpTo 25mm Thru Paint
