VEHICLE INSPECTION REPORT

DP70VPT

Nissan Qashqai 1.3 DiG-T 160 [157] N-Connecta 5dr DCT Glass Roof

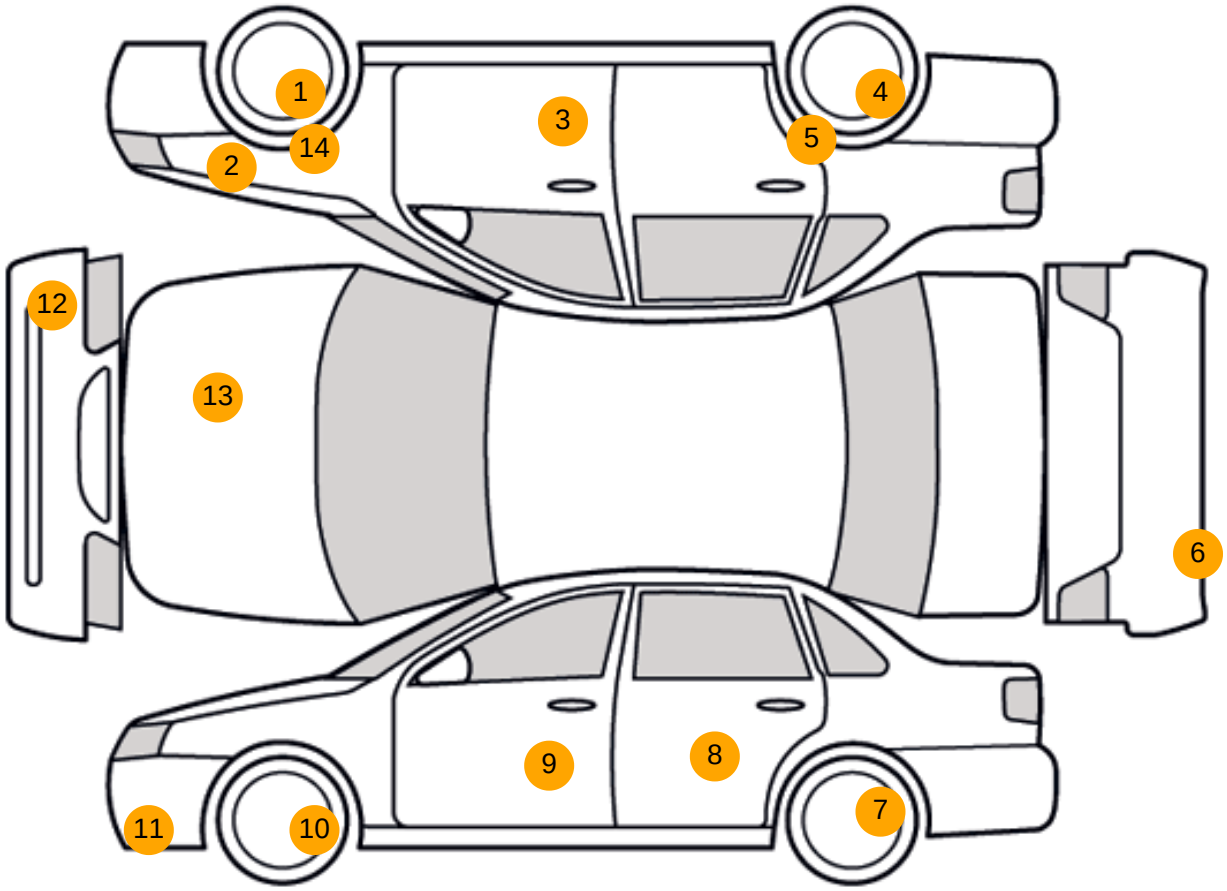
Condition Check

1: Wheel osf
Corroded
Light

2: Wing osf
Chipped
1 To 5

3: Door osf
Scratched
Over 25mm Thru Paint

4: Wheel osr
Corroded
Light

5: Door osr
Chipped
Edge Chip

6: Bumper Rear
Chipped
1 To 5

7: Wheel nsr
Corroded
Light

8: Door nsr
Chipped
1 To 5

9: Door nsf
Chipped
1 To 5

10: Wheel nsf
Corroded
Light

11: Bumper Front
Scratched
25 to 100mm Thru Paint

12: Bumper Front
Chipped
Multiple Chips

13: Bonnet
Chipped
1 To 5

14: Wing Front Arch Extension os
Scuffed (Unpainted)
UpTo 100mm
