VEHICLE INSPECTION REPORT

LB71XOX

Volkswagen Tiguan 1.4 TSI eHybrid R-Line 5dr DSG

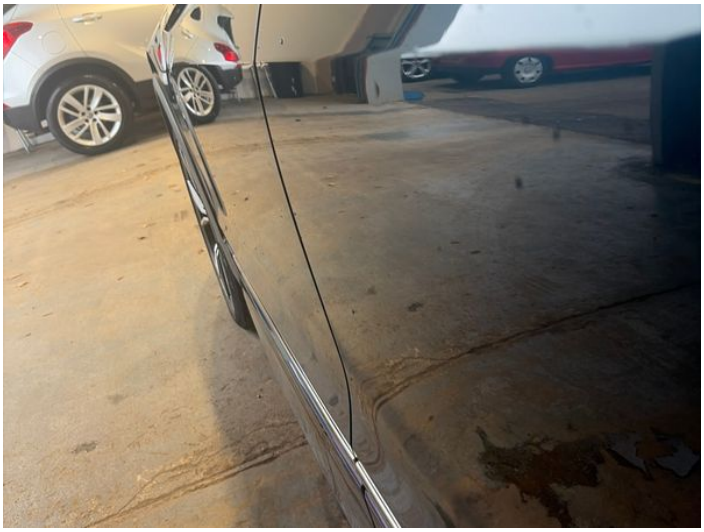
1: Wheel osf
Scratched
Over 50mm

2: Door osf
Poor Previous Repair
Poor Paint

3: Door osr
Chipped
1 To 5

4: Door osr
Dented
2 Or Less UpTo 10mm

5: Bumper Rear
Scratched
Up To 25mm Thru Paint

6: Bumper Rear
Chipped
1 To 5

7: Wheel nsr
Scratched
Over 50mm

8: Door nsr
Chipped
1 To 5

9: Door nsr
Dented
2 Or Less UpTo 10mm

10: Wheel nsf
Scratched
Over 50mm

11: Bonnet
Chipped
1 To 5

12: Seat Back Cover osf
Holed
Over 3mm
