VEHICLE INSPECTION REPORT

KT68VGE

Kia Niro 1.6 GDi Hybrid 2 5dr DCT

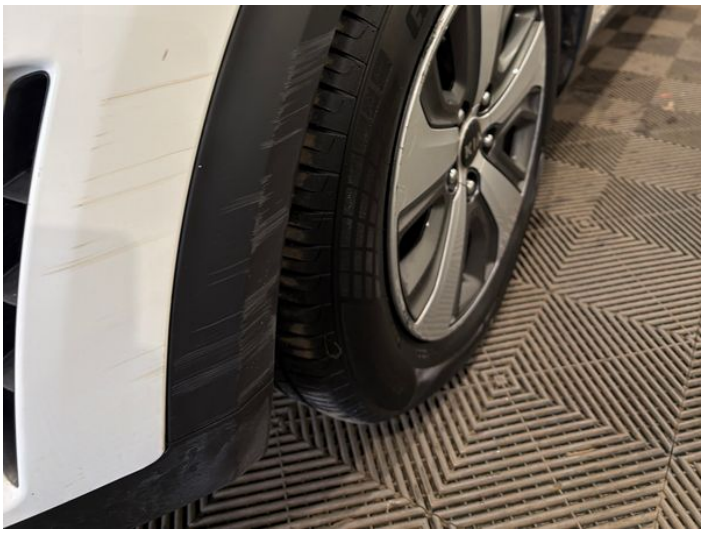
1: Tyre osf
Damaged
Replace

2: Tyre nsr
Damaged
Replace

3: Bonnet
Chipped
1 To 5

4: Bumper Front
Scratched
25 to 100mm Thru Paint

5: Wing Front Arch Extension ns
Scuffed (Unpainted)
Over 100mm

6: Door nsf
Poor Previous Repair
Poor Paint

7: Door nsr
Dented
With Paint Damage

8: Qtr Panel Arch Extension ns
Scuffed (Unpainted)
Over 100mm

9: Bumper Rear
Scratched
Over 100mm Thru Paint

10: Boot Lid
Chipped
1 To 5

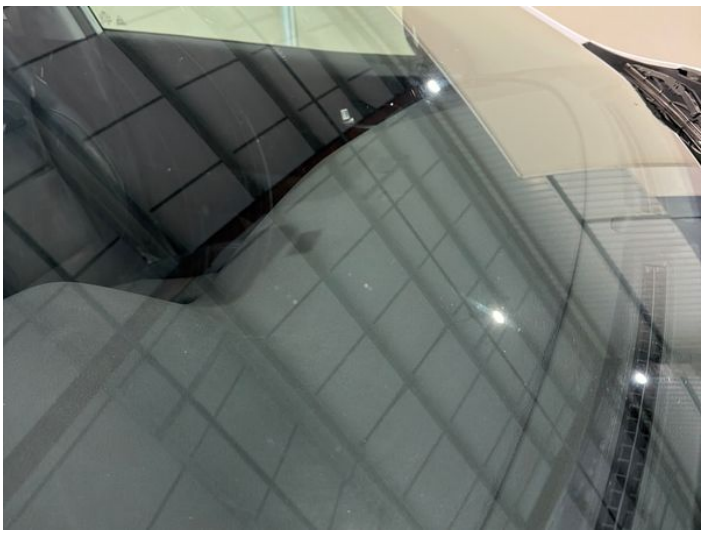
11: Door osr
Chipped
Edge Chip

12: Door osf
Chipped
Edge Chip

13: Wing osf
Scratched
Over 25mm Thru Paint

14: Screen Front
Chipped
UpTo 10mm
