VEHICLE INSPECTION REPORT

YM18HZC

Volvo V60 T4 [190] R DESIGN Nav 5dr

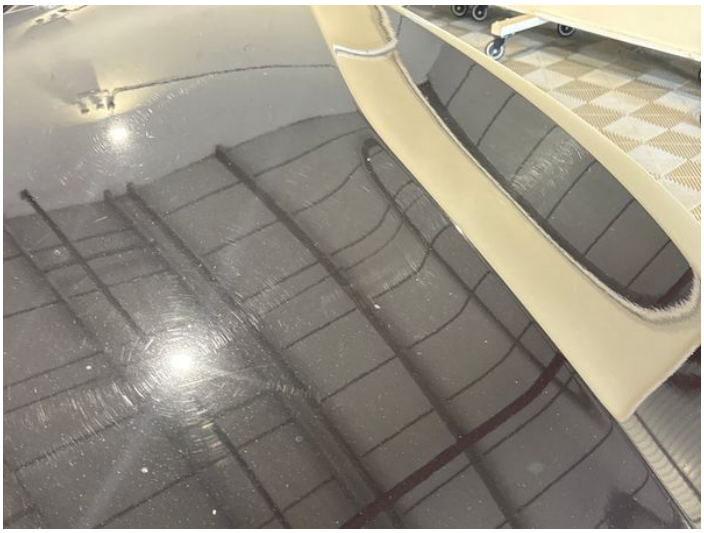
1: Bonnet
Chipped
Multiple Chips

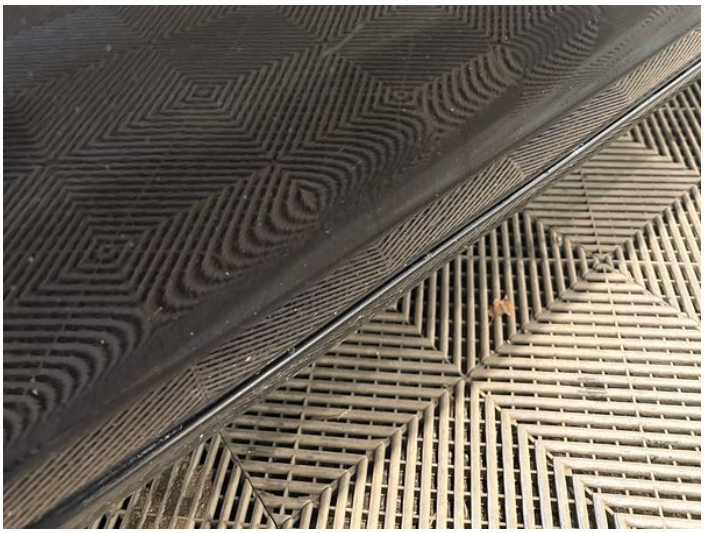
2: Bumper Front
Scratched
Over 100mm Thru Paint

3: Wing nsf
Scratched
Over 25mm Thru Paint

4: Wheel nsf
Scratched
Over 50mm

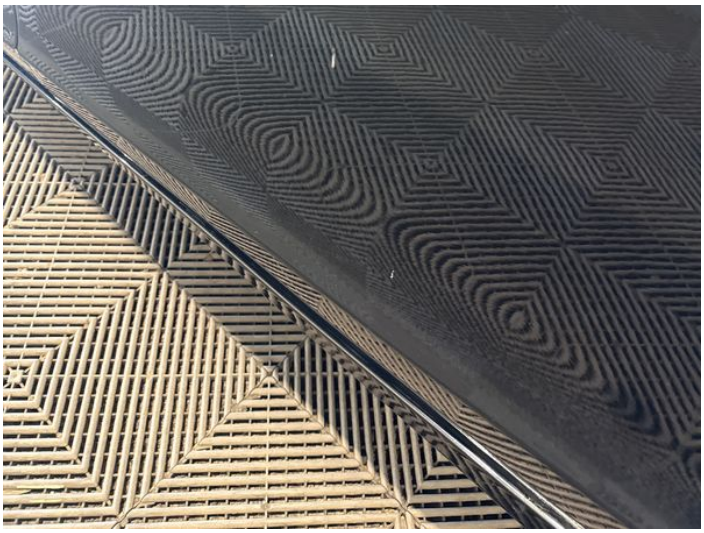
5: Door nsf
Scratched
UpTo 25mm Thru Paint

6: Door nsr
Scratched
UpTo 25mm Thru Paint

7: Wheel nsr
Scratched
Up To 50mm

8: Qtr Panel nsr
Scratched
Over 25mm Thru Paint

9: Bumper Rear
Scratched
Over 100mm Thru Paint

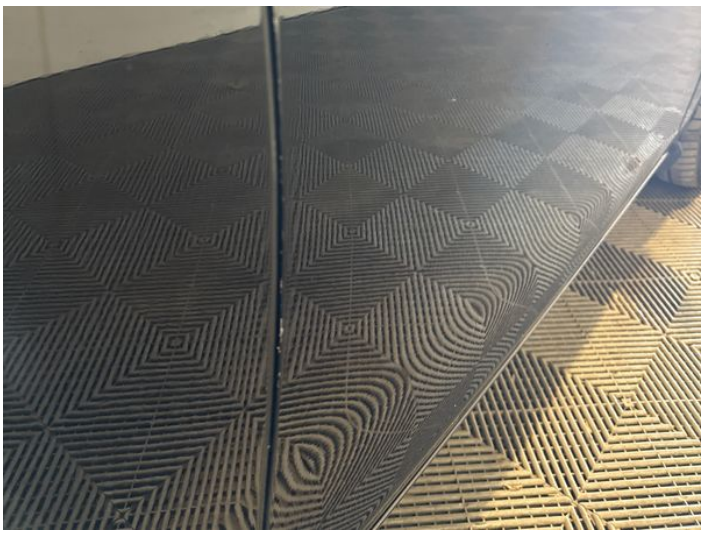
10: Qtr Panel osr
Chipped
Over 5mm

11: Wheel osr
Scratched
Over 50mm

12: Door osr
Chipped
Edge Chip

13: Door osf
Chipped
Edge Chip

14: Wing osf
Chipped
1 To 5

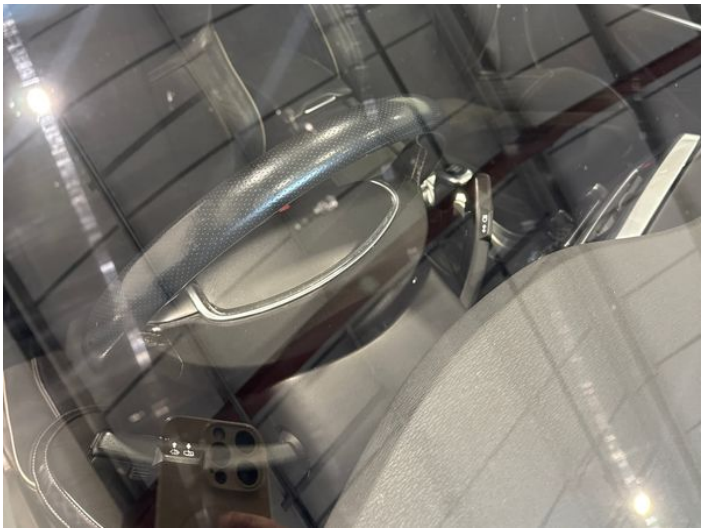
15: Wheel osf
Scratched
Over 50mm

16: Screen Front
Scratched
UpTo 30mm

17: Roof
Chipped
1 To 5

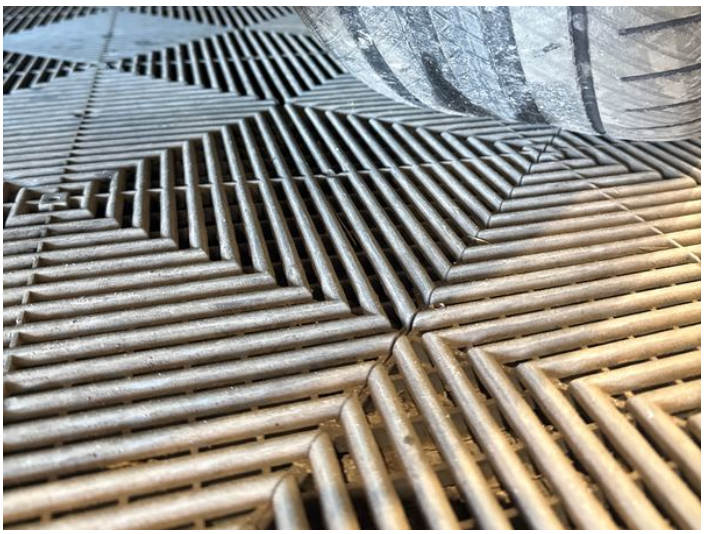
18: Tyre osf
Damaged
Replace

19: Tyre nsf
Damaged
Replace

20: Switches And Controls
Missing
Replace
