VEHICLE INSPECTION REPORT

EJ67VHO

Volvo XC60 2.0 D5 PowerPulse R DESIGN Pro 5dr AWD Geartronic

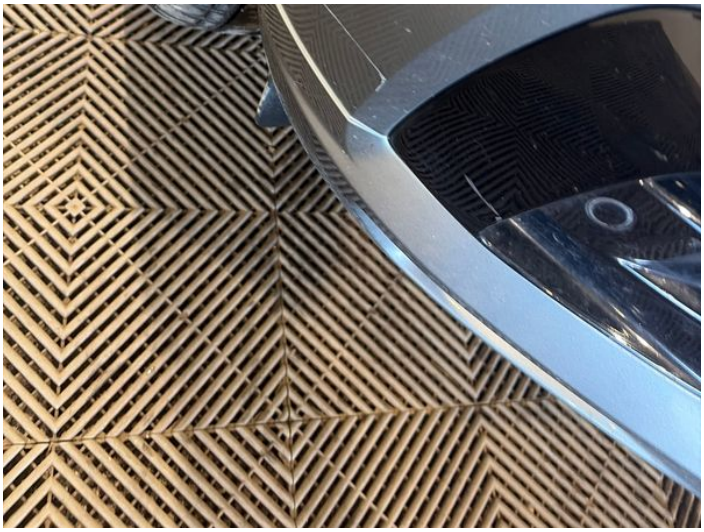
1: Wheel osf
Scratched
Over 50mm

2: Door osf
Scratched
Over 25mm Thru Paint

3: Wheel osr
Scratched
Over 50mm

4: Bumper Rear
Chipped
Multiple Chips

5: Boot Lid
Dented
With Paint Damage

6: Wheel nsr
Scratched
Over 50mm

7: Door nsf
Chipped
1 To 5

8: Wheel nsf
Scratched
Over 50mm

9: Bumper Front
Scratched
25 to 100mm Thru Paint

10: Bumper Front
Chipped
Multiple Chips

11: Screen Front
Chipped
UpTo 10mm
