VEHICLE INSPECTION REPORT

GY25XNO

BMW 2 Series 220i MHT M Sport 5dr DCT

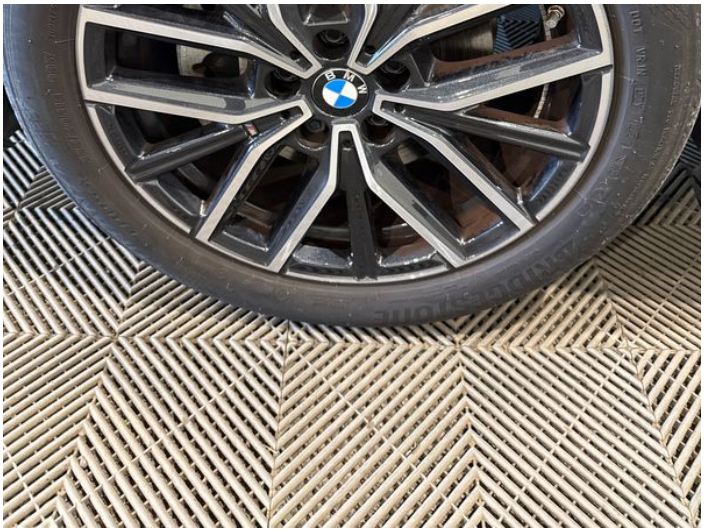
1: Bonnet
Chipped
1 To 5

2: Bumper Front
Scratched
25 to 100mm Thru Paint

3: Wheel nsf
Scratched
Up To 50mm

4: Wing nsf
Chipped
Edge Chip

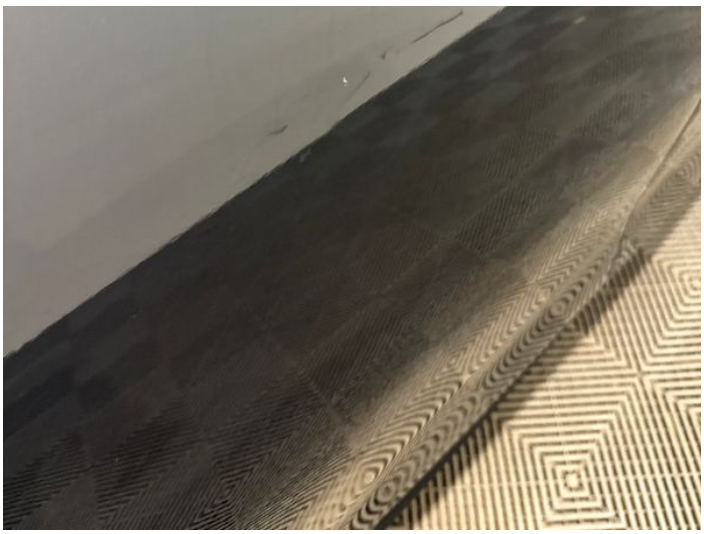
5: Door nsr
Dented
Over 2 UpTo 10mm

6: Qtr Panel nsr
Chipped
1 To 5

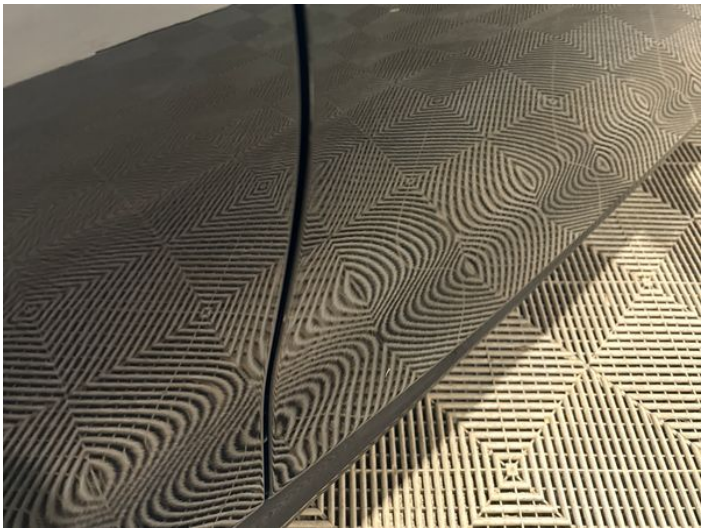
7: Qtr Panel osr
Chipped
1 To 5

8: Door osr
Chipped
1 To 5

9: Door osf
Scratched
UpTo 25mm Thru Paint

10: Door osf
Chipped
Edge Chip

11: Wing osf
Chipped
1 To 5
