VEHICLE INSPECTION REPORT

GD18RXP

Renault Kadjar 1.2 TCE Dynamique S Nav 5dr

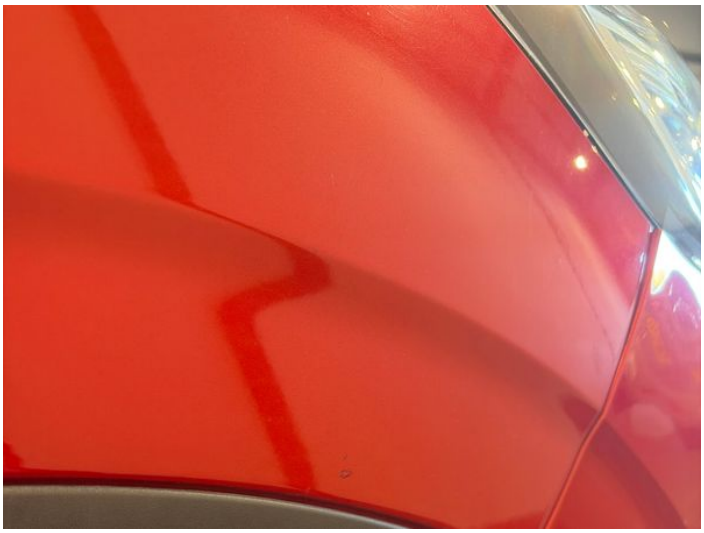
Damage Photos

1: Wheel osf
Scratched
Over 50mm

2: Wing osf
Chipped
1 To 5

3: Door osf
Chipped
Edge Chip

4: Door osr
Chipped
1 To 5

5: Door osr
Dented
2 Or Less UpTo 10mm

6: Wheel osr
Scratched
Over 50mm

7: Qtr Panel osr
Dented
Over 30mm

8: Bumper Rear
Cracked
Over 25mm

9: Qtr Panel nsr
Scratched
UpTo 25mm Thru Paint

10: Wheel nsr
Corroded
Light

11: Door nsf
Scratched
Over 25mm Thru Paint

12: Wheel nsf
Corroded
Light

13: Bonnet
Chipped
1 To 5

14: Bumper Front
Scratched
25 to 100mm Thru Paint

15: Roof
Chipped
1 To 5

16: Seat Base Cover osf
Scuffed
Over 25mm
