VEHICLE INSPECTION REPORT

KY23FFU

Land Rover Range Rover Evoque 2.0 D200 Evoque Edition 5dr Auto

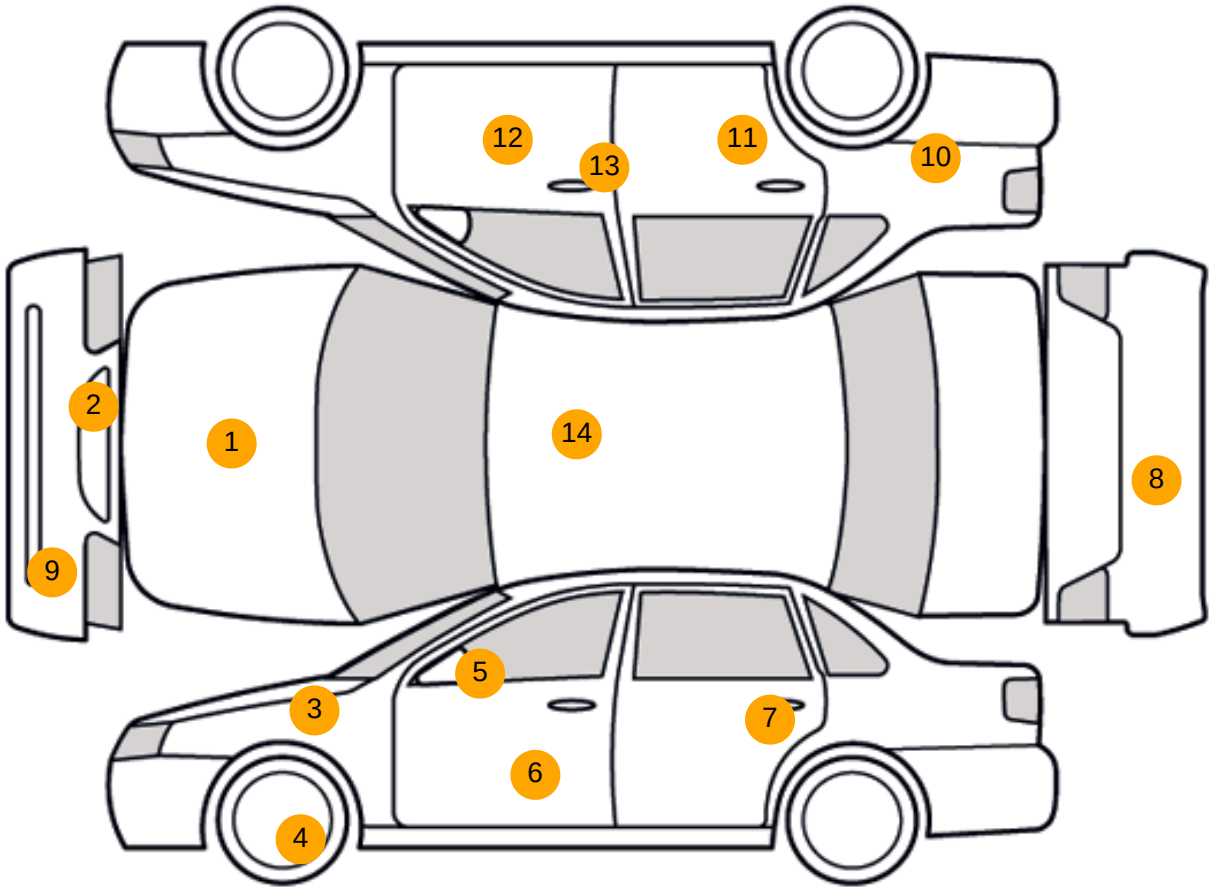
1: Seat Back Cover nsf
Scuffed
UpTo 25mm

2: Bonnet
Chipped
1 To 5

3: Bumper Front
Scratched
25 to 100mm Thru Paint

4: Wing nsf
Scratched
Over 25mm Thru Paint

5: Wheel nsf
Scratched
Over 50mm

6: Door Mirror Assy nsf
Scratched (Painted)
Over 25mm Thru Paint

7: Door nsf
Scratched
Over 25mm Thru Paint

8: Door nsr
Scratched
Over 25mm Thru Paint

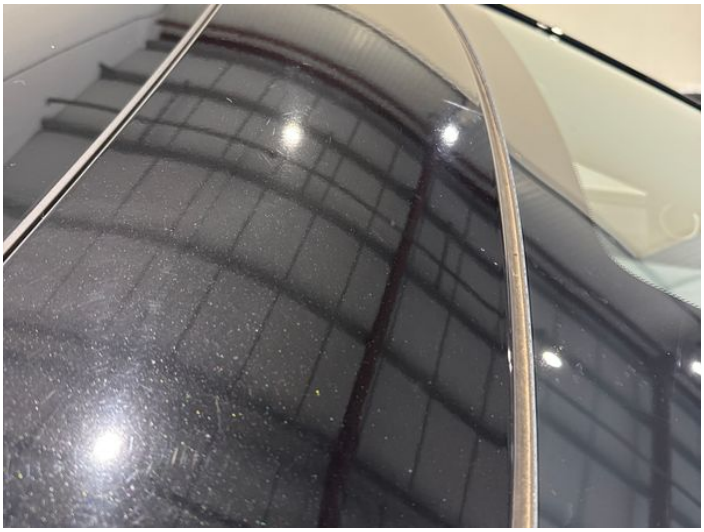
14: Door osf
Dented
Between 10mm + 30mm

15: Roof
Chipped
1 To 5
