VEHICLE INSPECTION REPORT

PK64ENY

Citroen DS3 1.6 e-HDi Airdream DStyle Plus 3dr

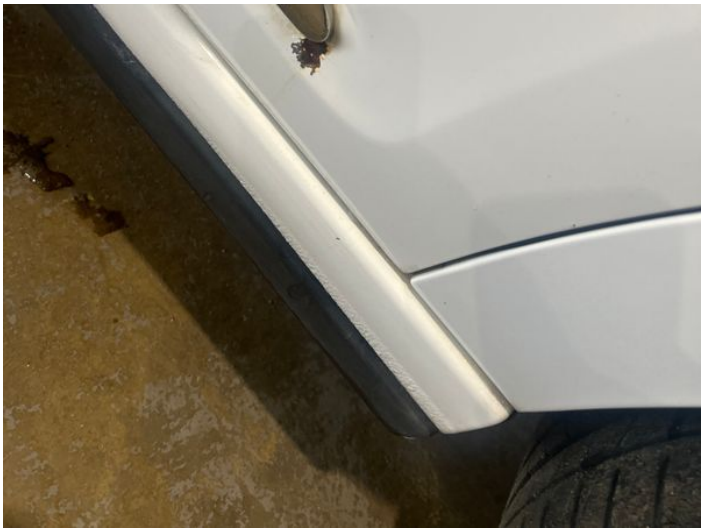
1: Wheel osf
Scratched
Over 50mm
