VEHICLE INSPECTION REPORT

OE19HVD

Jaguar XF 2.0i R-Sport 5dr Auto

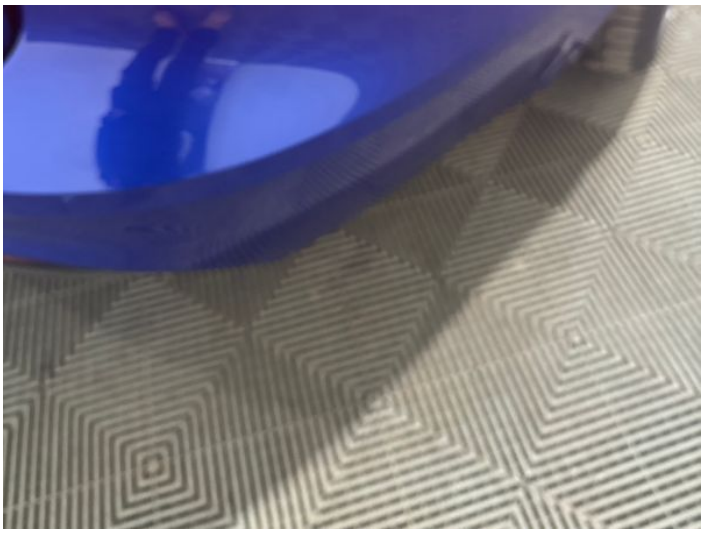
4: Wing nsf
Scratched
UpTo 25mm Thru Paint

5: Wheel nsf
Scratched
Over 50mm

6: Door nsf
Dented
Over 30mm

7: Door nsf
Chipped
1 To 5

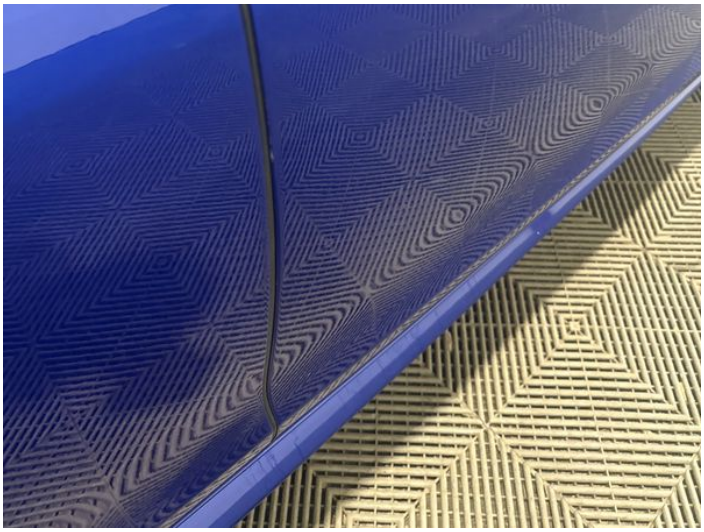
8: Door nsr
Chipped
1 To 5

9: Wheel nsr
Scratched
Over 50mm

10: Qtr Panel nsr
Scratched
Over 25mm Thru Paint

11: Bumper Rear
Poor Previous Repair
Poor Paint
