VEHICLE INSPECTION REPORT

GY71AXK

Kia Xceed 1.5T GDi ISG 3 5dr

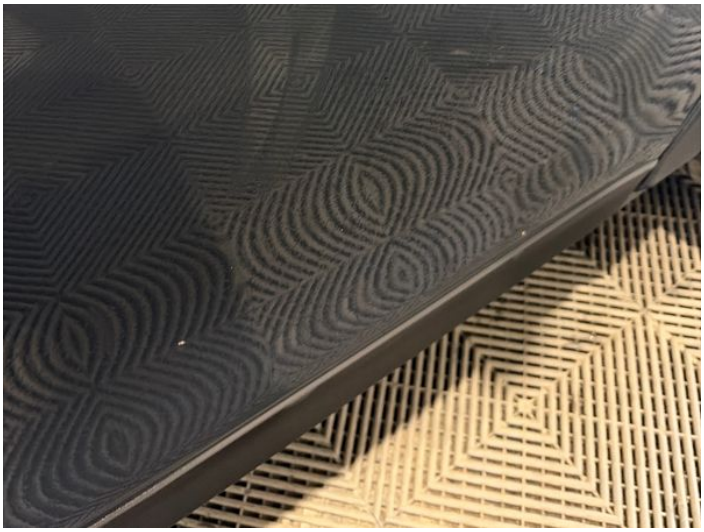
1: Wheel osf
Scratched
Over 50mm

2: Wing osf
Chipped
1 To 5

3: Wheel osr
Corroded
Light

4: Door osf
Chipped
1 To 5

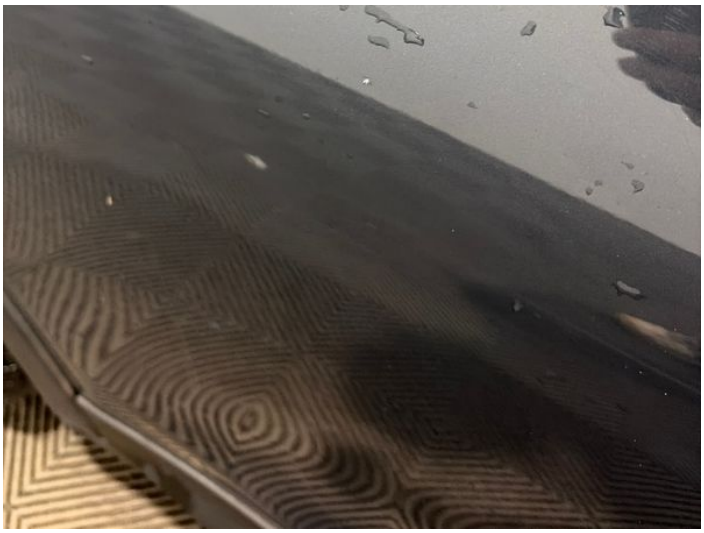
5: Door osr
Chipped
1 To 5

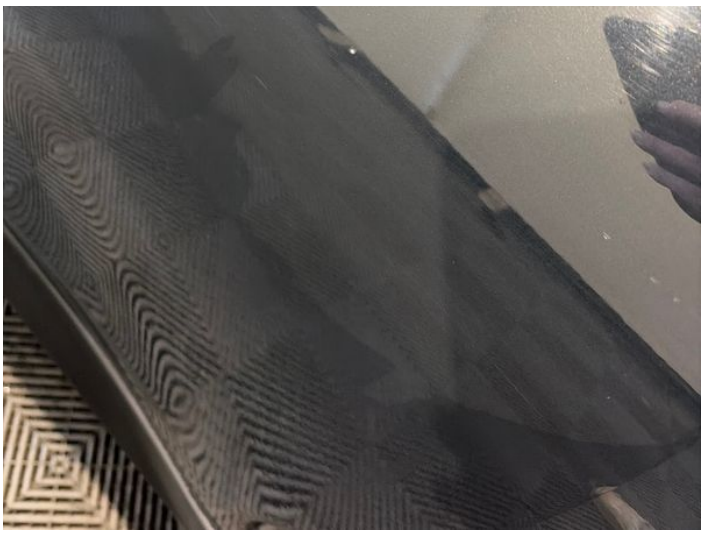
6: Bumper Rear
Chipped
1 To 5

7: Door nsr
Chipped
1 To 5

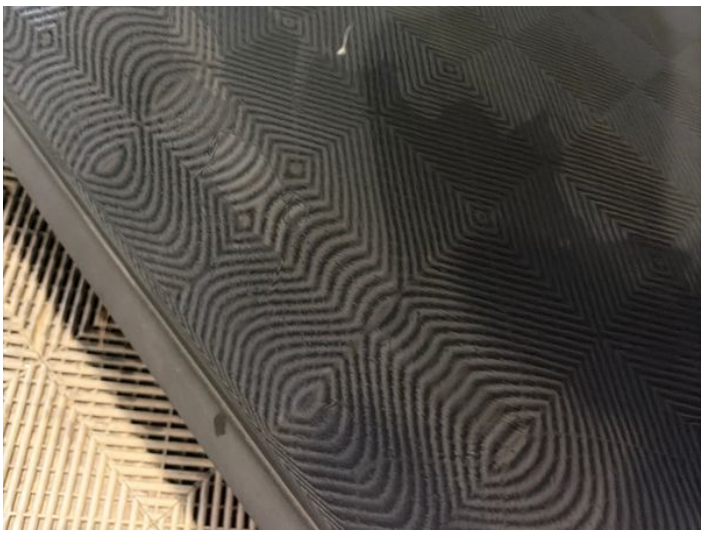
8: Door nsf
Scratched
UpTo 25mm Thru Paint

9: Wheel nsf
Scratched
Over 50mm

10: Bumper Front
Scratched
25 to 100mm Thru Paint

11: Bumper Front
Chipped
Multiple Chips

12: Bonnet
Dented
Between 10mm + 30mm

13: Bonnet
Chipped
1 To 5

14: Roof
Dented
Between 10mm + 30mm
