VEHICLE INSPECTION REPORT

GV16MMK

Nissan Qashqai 1.2 DiG-T Tekna [Non-Panoramic] 5dr Xtronic

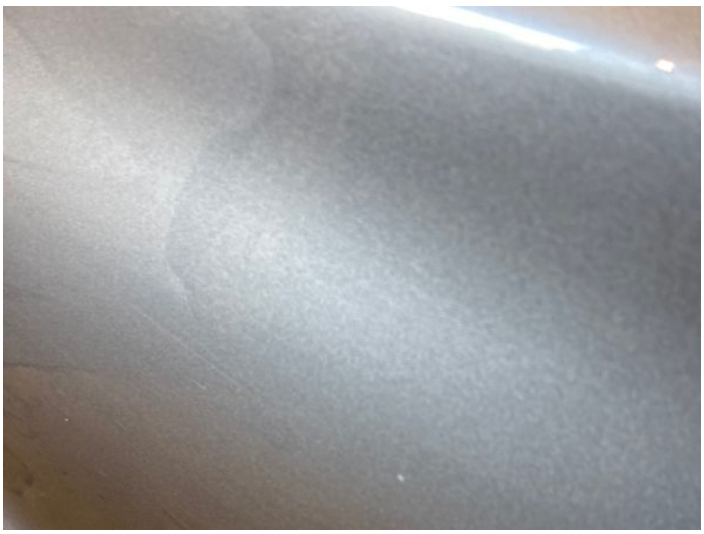
1: Wheel osf
Corroded
Light

2: Wing osf
Scratched
UpTo 25mm Thru Paint

3: Door osr
Scratched
Over 25mm Thru Paint
