# VEHICLE INSPECTION REPORT

**LV67FWA**

## Skoda Kodiaq 2.0 TSI SE L 4x4 5dr DSG [7 Seat]

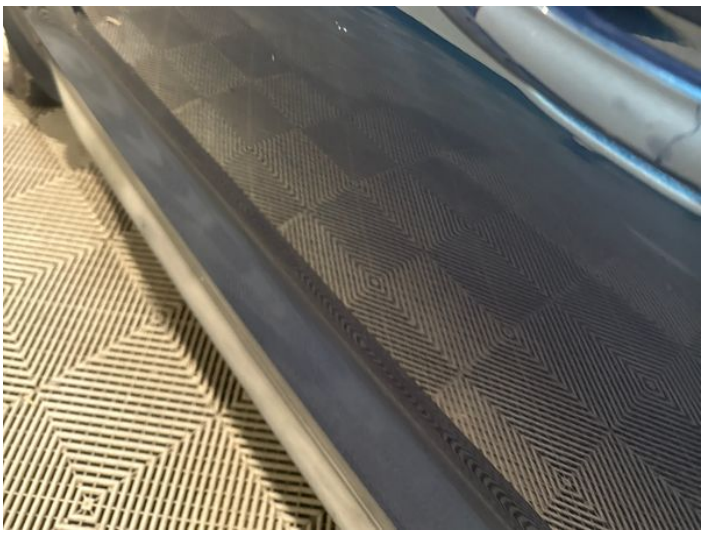
2: Bumper Front
Scratched
Over 100mm Thru Paint

3: Bumper Front Moulding
Scuffed (Unpainted)
Over 100mm

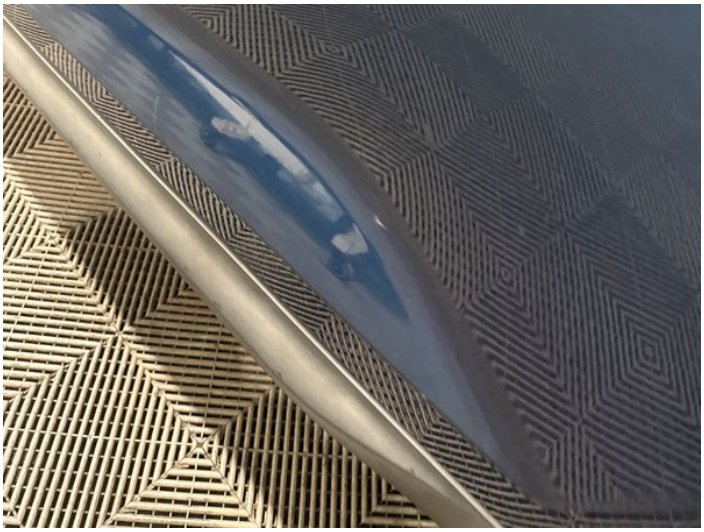
4: Wing nsf
Scratched
UpTo 25mm Thru Paint

5: Wheel nsf
Scratched
Up To 50mm

6: A Post ns
Chipped
1 To 5

7: Door nsf
Dented
2 Or Less UpTo 10mm
