VEHICLE INSPECTION REPORT

KY58YHW

Mercedes-Benz C Class C 200 CDI ELEGANCE

Eastbourne Car Auctions

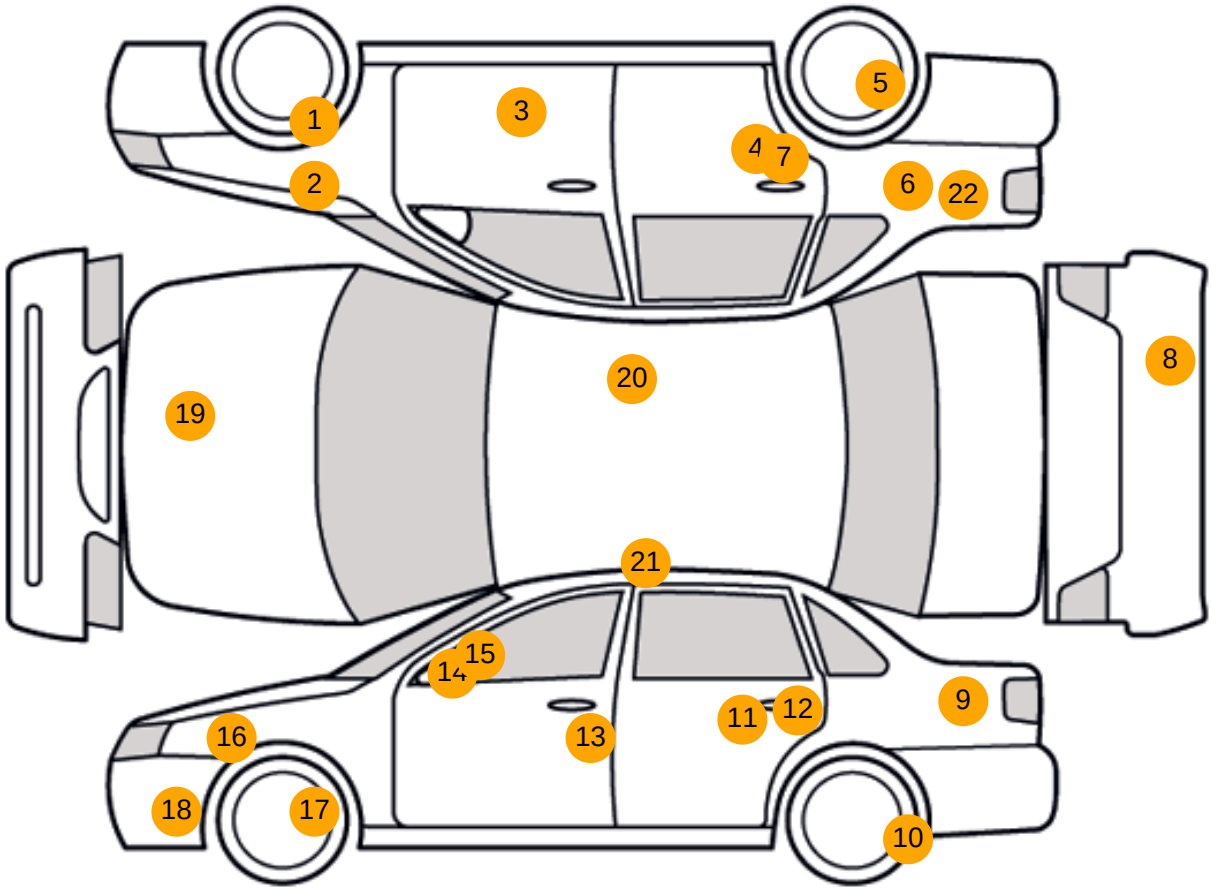
Damage Photos

1: Wheel osf
Scratched
Over 50mm

2: Wing osf
Chipped
1 To 5

3: Door osf
Chipped
Multiple Chips

4: Door osr
Chipped
1 To 5

5: Wheel osr
Corroded
Light

6: Qtr Panel osr
Chipped
1 To 5

7: Door osr
Chipped
Edge Chip

8: Bumper Rear
Poor Previous Repair
Paint Flake

9: Qtr Panel nsr
Scratched
Over 25mm Thru Paint

10: Wheel nsr
Corroded
Light

11: Door nsr
Chipped
1 To 5

12: Door nsr
Chipped
Edge Chip

13: Door nsf
Chipped
1 To 5

14: Door Mirror Glass ns
Broken
Replace

15: Door Mirror Assy nsf
Scratched (Painted)
Over 25mm Thru Paint

16: Wing nsf
Scratched
UpTo 25mm Thru Paint

17: Wheel nsf
Scratched
Over 50mm

18: Bumper Front
Scratched
25 to 100mm Thru Paint

19: Bonnet
Chipped
1 To 5

22: Qtr Panel osr
Dented
Between 10mm + 30mm

23: Seat Base Cover osf
Scuffed
Over 25mm
