VEHICLE INSPECTION REPORT

PN13EXP

Honda Jazz 1.4 i-VTEC EX 5dr

Cat: S

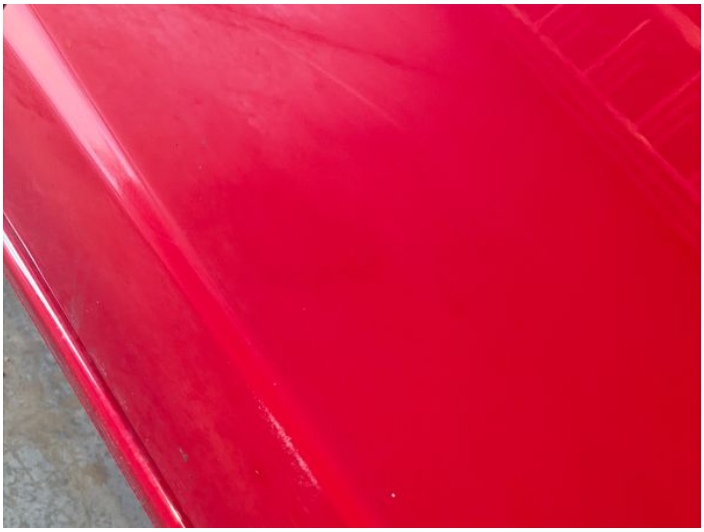
1: Wheel osf
Scratched
Over 50mm

2: Wing osf
Chipped
1 To 5

3: Door osf
Scratched
Over 25mm Thru Paint

4: Door osr
Scratched
Over 25mm Thru Paint

5: Qtr Panel osr
Dented
With Paint Damage

6: Wheel osr
Scratched
Over 50mm

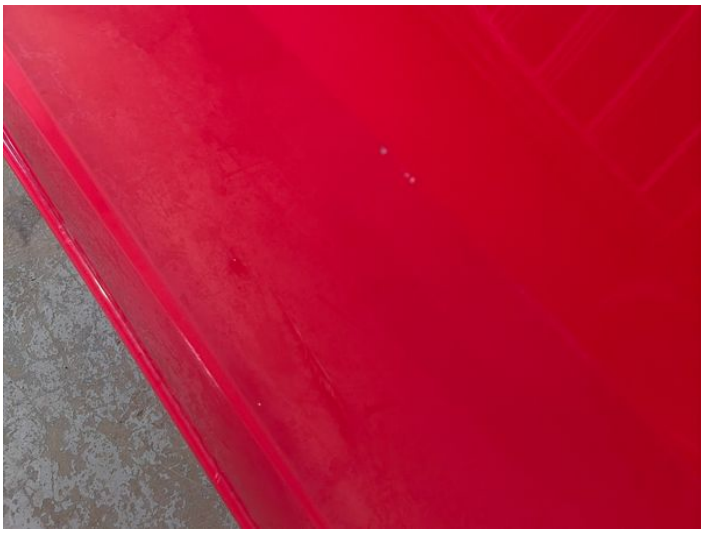
7: Boot Lid
Dented
With Paint Damage

8: Qtr Panel nsr
Dented
Over 30mm

9: Wheel nsr
Scratched
Over 50mm
