VEHICLE INSPECTION REPORT

RX16XAO

Citroen C4 1.2 PureTech Flair 5dr

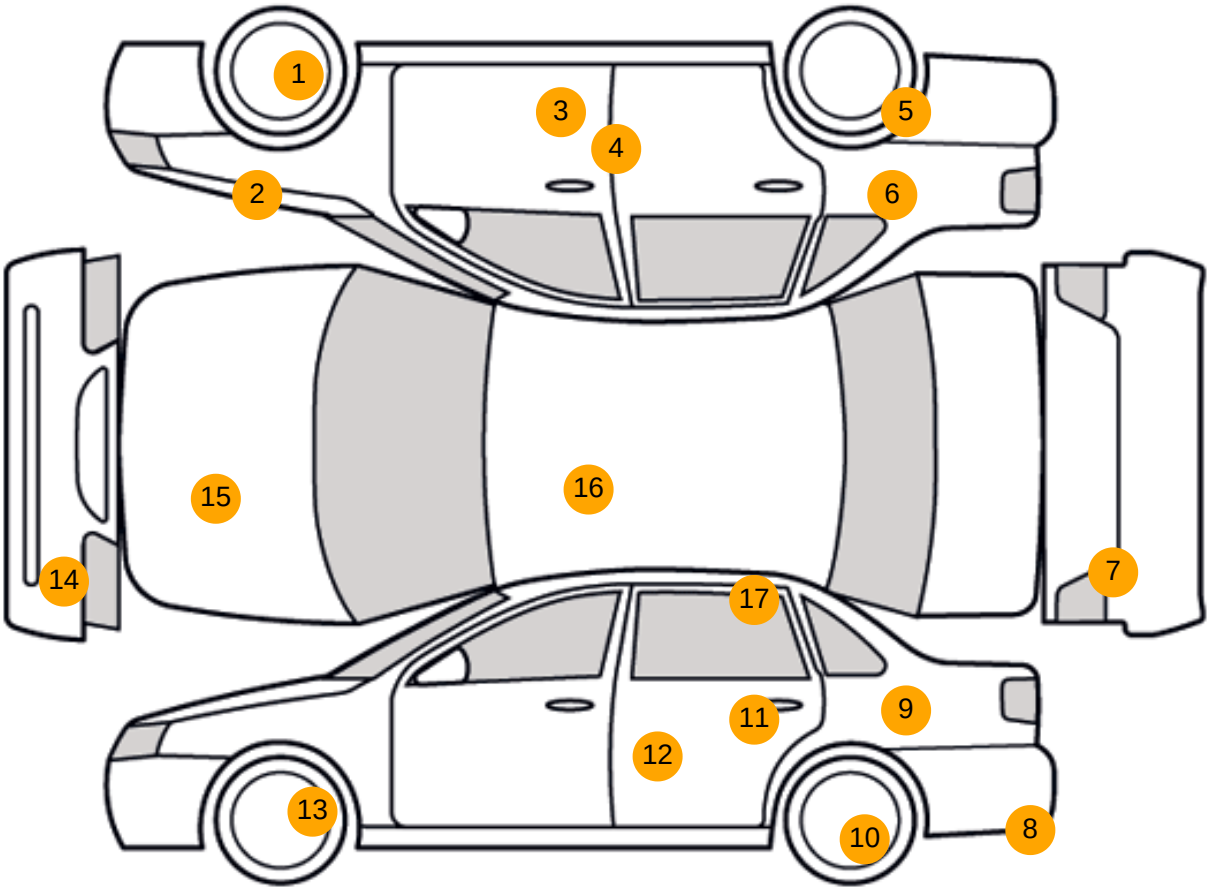
1: Wheel osf
Scratched
Over 50mm

2: Wing osf
Chipped
1 To 5

3: Door osf
Scratched
UpTo 25mm Thru Paint

4: Door osf
Chipped
Edge Chip

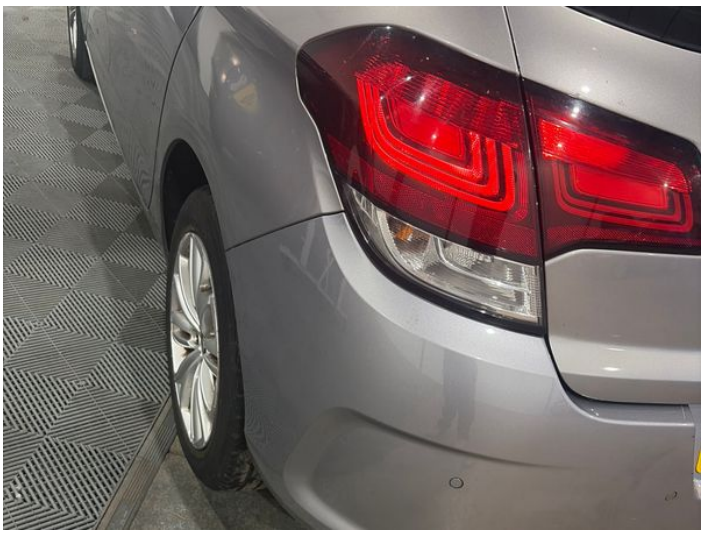
5: Wheel osr
Scratched
Over 50mm

6: Qtr Panel osr
Scratched
UpTo 25mm Thru Paint

7: Boot Lid
Scratched
UpTo 25mm Thru Paint

8: Bumper Rear
Poor Previous Repair
Poor Colour

9: Qtr Panel nsr
Chipped
1 To 5

10: Wheel nsr
Scratched
Over 50mm

11: Door nsr
Chipped
1 To 5

12: Door nsr
Scratched
UpTo 25mm Thru Paint

13: Wheel nsf
Scratched
Over 50mm

14: Bumper Front
Scratched
Over 100mm Thru Paint

15: Bonnet
Chipped
1 To 5

16: Roof
Dented
Hail - Moderate

17: C Post ns
Dented
Between 10mm + 30mm
